Access Compliance Report

Public Rights-of-Way

(Island Curb Cuts)

Intersection ID: 21949	Main Street: SHARON_VIEW_RD	Cross Street: SUTTON_SPRINGS_RD	Location: NE
ADA ID: DA623801222C	Curb Cut Type: MedianRefuge2	Initial Pass/Fail: Fail	Overall Compliance: No
Severity Score: 1.25			
Codes/Mitigation Info/Possible Solution		Field Measurements/Component Compliance

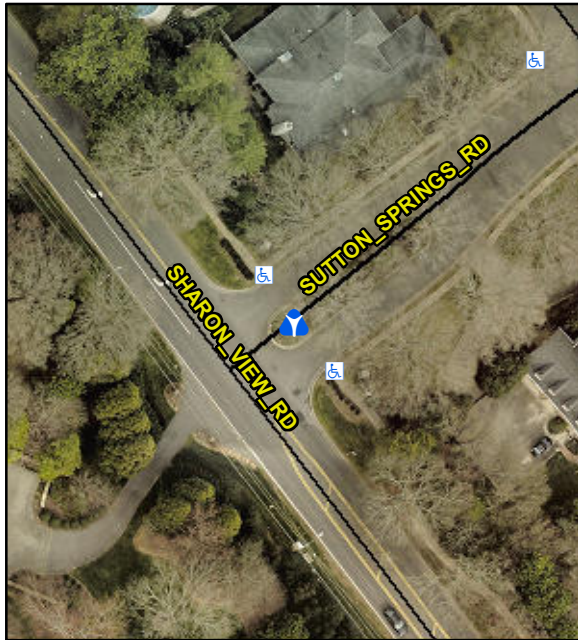
Compliance	Description	Data	Compliance	Description	Data
Yes	Refuge 1 Length (In)	108.0	N/A	Gutter 1 Ponding?	N/A
Yes	Refuge 1 Width (In)	60.0	N/A	Gutter 1 Lip Ht (In)	N/A
Yes	Refuge 1 Slope (%)	3.6	N/A	Gutter 1 Slope (%)	N/A
Yes	Refuge 1 X Slope (%)	3.8	N/A	Gutter 1 X Slope (%)	N/A
N/A	Painted X Walk1?	No	N/A	DWS 1 Provided?	N/A
N/A	X Walk 1 Direction	To NW	N/A	DWS 1 Contrast?	N/A
N/A	X Walk 1 Width (In)	N/A	N/A	DWS 1 Length (In)	N/A
N/A	Road 1 Slope (%)	1.3	N/A	DWS 1 Full Width?	N/A
N/A	Road 1 X Slope (%)	4.6	N/A	DWS 1 Offset (In)	N/A
Yes	Refuge 2 Length (In)	108.0	N/A	Gutter 2 Ponding?	N/A
Yes	Refuge 2 Width (In)	60.0	N/A	Gutter 2 Lip Ht (In)	N/A
Yes	Refuge 2 Slope (%)	1.6	N/A	Gutter 2 Slope (%)	N/A
Yes	Refuge 2 X Slope (%)	3.9	N/A	Gutter 2 X Slope (%)	N/A
N/A	Painted X Walk2?	No	N/A	DWS 2 Provided?	N/A
N/A	X Walk 2 Direction	To SE	N/A	DWS 2 Contrast?	N/A
N/A	X Walk 2 Width (In)	N/A	N/A	DWS 2 Length (In)	N/A

N/A	Road 2 Slope (%)	3.0	N/A	DWS 2 Full Width?	N/A
N/A	Road 2 X Slope (%)	5.8	N/A	DWS 2 Offset (In)	N/A
N/A	Refuge 3 Length (in)	N/A	N/A	Gutter 3 Ponding?	N/A
N/A	Refuge 3 Width (in)	N/A	N/A	Gutter 3 Lip Ht (in)	N/A
N/A	Refuge 3 Slope (%)	N/A	N/A	Gutter 3 Slope (%)	N/A
N/A	Refuge 3 XSlope (%)	N/A	N/A	Gutter 3 XSlope (%)	N/A
N/A	Painted X Walk3?	N/A	N/A	DWS 3 Provided?	N/A
N/A	X Walk 3 Direction	N/A	N/A	DWS 3 Contrast?	N/A
N/A	X Walk 3 Width (in)	N/A	N/A	DWS 3 Length (in)	N/A
N/A	Road 3 Slope (%)	N/A	N/A	DWS 3 Full Width?	N/A
N/A	Road 3 XSlope (%)	N/A	N/A	DWS 3 Offset (in)	N/A
Yes	Any Obstructions?	N/A	N/A	Storm Grate/Utility Hazard?	N/A
N/A	Obstruction Type		N/A	Storm Grate/Utility Type	
		N/A			N/A
N/A	Surface Condition	Good

Possible Solutions:

Remove & Replace Entire Refuge.

Total Cost:

\$ 3000.00
