Access Compliance Report

Public Rights-of-Way

(Island Curb Cuts)

Intersection ID: 12640	Main Street: W_MOREHEAD_ST	Cross Street: WILKINSON_BV	Location: SE
ADA ID: DCA7226F0538	Curb Cut Type: MedianRefuge2	Initial Pass/Fail: Fail	Overall Compliance: No
Codes/Mitigation Info/Possible Solution		Field Measurements/Component Compliance	
Severity Score: 0

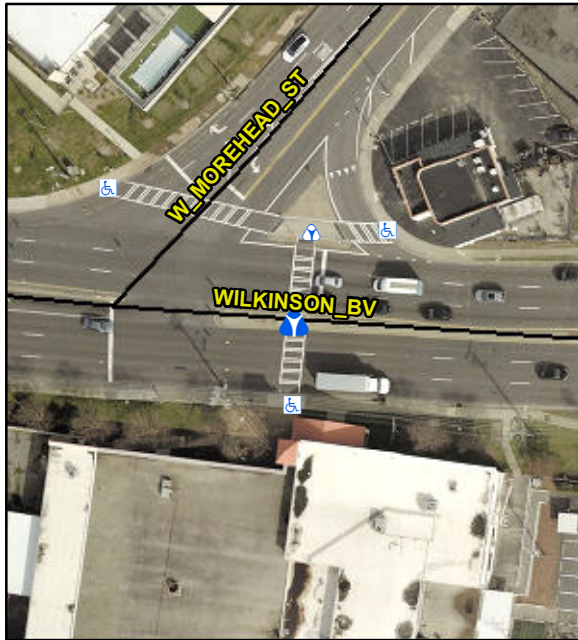
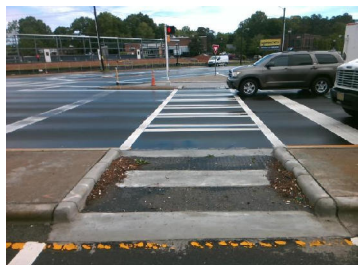
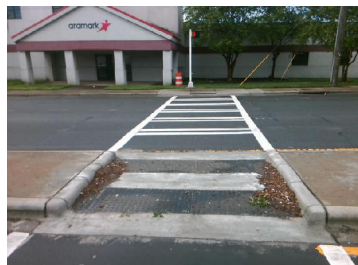
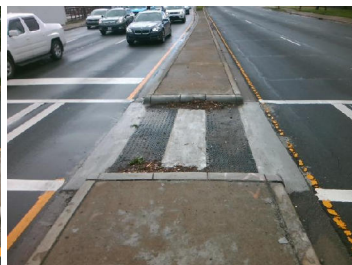
Compliance	Description	Data	Compliance	Description	Data
Yes	Refuge 1 Length (In)	36.0	N/A	Gutter 1 Ponding?	N/A
Yes	Refuge 1 Width (In)	105.0	N/A	Gutter 1 Lip Ht (In)	N/A
Yes	Refuge 1 Slope (%)	0.6	N/A	Gutter 1 Slope (%)	N/A
Yes	Refuge 1 X Slope (%)	1.3	N/A	Gutter 1 X Slope (%)	N/A
N/A	Painted X Walk1?	Yes	N/A	DWS 1 Provided?	N/A
N/A	X Walk 1 Direction	To N	N/A	DWS 1 Contrast?	N/A
N/A	X Walk 1 Width (In)	112.0	N/A	DWS 1 Length (In)	N/A
N/A	Road 1 Slope (%)	0.2	N/A	DWS 1 Full Width?	N/A
N/A	Road 1 X Slope (%)	1.2	N/A	DWS 1 Offset (In)	N/A
Yes	Refuge 2 Length (In)	36.0	N/A	Gutter 2 Ponding?	N/A
Yes	Refuge 2 Width (In)	105.0	N/A	Gutter 2 Lip Ht (In)	N/A
Yes	Refuge 2 Slope (%)	1.0	N/A	Gutter 2 Slope (%)	N/A
Yes	Refuge 2 X Slope (%)	2.1	N/A	Gutter 2 X Slope (%)	N/A
N/A	Painted X Walk2?	Yes	N/A	DWS 2 Provided?	N/A
N/A	X Walk 2 Direction	To S	N/A	DWS 2 Contrast?	N/A
N/A	X Walk 2 Width (In)	113.0	N/A	DWS 2 Length (In)	N/A

N/A	Road 2 Slope (%)	1.1	N/A	DWS 2 Full Width?	N/A
N/A	Road 2 X Slope (%)	0.3	N/A	DWS 2 Offset (In)	N/A
N/A	Refuge 3 Length (in)	N/A	N/A	Gutter 3 Ponding?	N/A
N/A	Refuge 3 Width (in)	N/A	N/A	Gutter 3 Lip Ht (in)	N/A
N/A	Refuge 3 Slope (%)	N/A	N/A	Gutter 3 Slope (%)	N/A
N/A	Refuge 3 XSlope (%)	N/A	N/A	Gutter 3 XSlope (%)	N/A
N/A	Painted X Walk3?	N/A	N/A	DWS 3 Provided?	N/A
N/A	X Walk 3 Direction	N/A	N/A	DWS 3 Contrast?	N/A
N/A	X Walk 3 Width (in)	N/A	N/A	DWS 3 Length (in)	N/A
N/A	Road 3 Slope (%)	N/A	N/A	DWS 3 Full Width?	N/A
N/A	Road 3 XSlope (%)	N/A	N/A	DWS 3 Offset (in)	N/A
Yes	Any Obstructions?	N/A	N/A	Storm Grate/Utility Hazard?	N/A
N/A	Obstruction Type		N/A	Storm Grate/Utility Type	
		N/A			N/A
N/A	Surface Condition	Good

Possible Solutions:

Remove & Replace Entire Refuge.

Total Cost: \$ 3000.00
