Access Compliance Report

Public Rights-of-Way

(Island Curb Cuts)

Intersection ID: 12542	Main Street: ASHLEY_RD	Cross Street: WILKINSON_BV	Location: NE
ADA ID: DE975797D786	Curb Cut Type: IslandRefuge3	Initial Pass/Fail: Fail	Overall Compliance: No
		Severity Score: 35

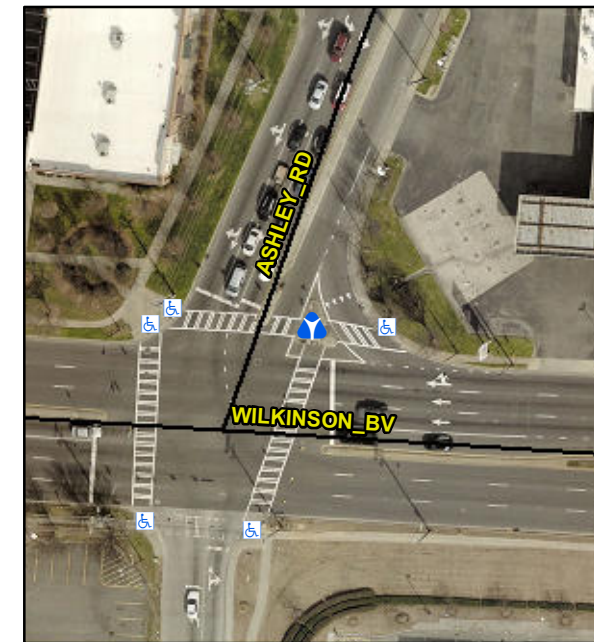
Compliance	Description	Data	Compliance	Description	Data
Yes	Refuge 1 Length (In)	80.0	N/A	Gutter 1 Ponding?	N/A
Yes	Refuge 1 Width (In)	85.0	N/A	Gutter 1 Lip Ht (In)	N/A
Yes	Refuge 1 Slope (%)	0.2	N/A	Gutter 1 Slope (%)	N/A
Yes	Refuge 1 X Slope (%)	1.2	N/A	Gutter 1 X Slope (%)	N/A
N/A	Painted X Walk1?	Yes	N/A	DWS 1 Provided?	N/A
N/A	X Walk 1 Direction	To W	N/A	DWS 1 Contrast?	N/A
N/A	X Walk 1 Width (In)	114.0	N/A	DWS 1 Length (In)	N/A
N/A	Road 1 Slope (%)	2.0	N/A	DWS 1 Full Width?	N/A
N/A	Road 1 X Slope (%)	0.2	N/A	DWS 1 Offset (In)	N/A
Yes	Refuge 2 Length (In)	40.0	N/A	Gutter 2 Ponding?	N/A
Yes	Refuge 2 Width (In)	80.0	N/A	Gutter 2 Lip Ht (In)	N/A
Yes	Refuge 2 Slope (%)	1.7	N/A	Gutter 2 Slope (%)	N/A
Yes	Refuge 2 X Slope (%)	0.2	N/A	Gutter 2 X Slope (%)	N/A
N/A	Painted X Walk2?	Yes	N/A	DWS 2 Provided?	N/A
N/A	X Walk 2 Direction	To E	N/A	DWS 2 Contrast?	N/A
N/A	X Walk 2 Width (In)	114.0	N/A	DWS 2 Length (In)	N/A

N/A	Road 2 Slope (%)	1.7	N/A	DWS 2 Full Width?	N/A
N/A	Road 2 X Slope (%)	2.5	N/A	DWS 2 Offset (In)	N/A
Yes	Refuge 3 Length (in)	80.0	N/A	Gutter 3 Ponding?	N/A
Yes	Refuge 3 Width (in)	62.0	N/A	Gutter 3 Lip Ht (in)	N/A
Yes	Refuge 3 Slope (%)	1.0	N/A	Gutter 3 Slope (%)	N/A
Yes	Refuge 3 XSlope (%)	2.1	N/A	Gutter 3 XSlope (%)	N/A
N/A	Painted X Walk3?	Yes	N/A	DWS 3 Provided?	N/A
N/A	X Walk 3 Direction	To S	N/A	DWS 3 Contrast?	N/A
N/A	X Walk 3 Width (in)	114.0	N/A	DWS 3 Length (in)	N/A
N/A	Road 3 Slope (%)	1.0	N/A	DWS 3 Full Width?	N/A
N/A	Road 3 XSlope (%)	1.7	N/A	DWS 3 Offset (in)	N/A
Yes	Any Obstructions?	N/A	N/A	Storm Grate/Utility Hazard?	N/A
N/A	Obstruction Type		N/A	Storm Grate/Utility Type	
		N/A			N/A
N/A	Surface Condition	N/A

Remove & Replace Entire Refuge.

\$ 3000.00
