Access Compliance Report

Public Rights-of-Way

(Island Curb Cuts)

Intersection ID: 51572	Main Street: FREEDOM_DR	Cross Street: WESLEY_VILLAGE_RD	Location: N
ADA ID: E13742A372EB	Curb Cut Type: MedianRefuge2	Initial Pass/Fail: Fail	Overall Compliance: No
Severity Score: 1.25			
Codes/Mitigation Info/Possible Solution		Field Measurements/Component Compliance

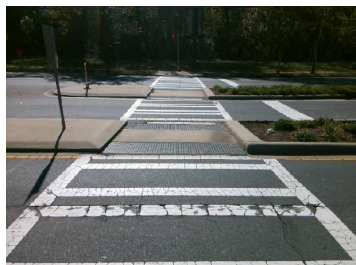
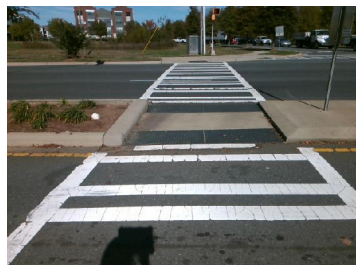
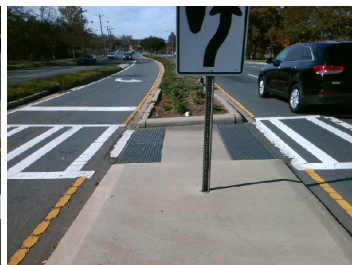
Compliance	Description	Data	Compliance	Description	Data
Yes	Refuge 1 Length (In)	45.0	N/A	Gutter 1 Ponding?	N/A
Yes	Refuge 1 Width (In)	95.0	N/A	Gutter 1 Lip Ht (In)	N/A
Yes	Refuge 1 Slope (%)	2.5	N/A	Gutter 1 Slope (%)	N/A
Yes	Refuge 1 X Slope (%)	1.5	N/A	Gutter 1 X Slope (%)	N/A
N/A	Painted X Walk1?	Yes	N/A	DWS 1 Provided?	N/A
N/A	X Walk 1 Direction	To N	N/A	DWS 1 Contrast?	N/A
N/A	X Walk 1 Width (In)	104.0	N/A	DWS 1 Length (In)	N/A
N/A	Road 1 Slope (%)	0.2	N/A	DWS 1 Full Width?	N/A
N/A	Road 1 X Slope (%)	5.2	N/A	DWS 1 Offset (In)	N/A
Yes	Refuge 2 Length (In)	45.0	N/A	Gutter 2 Ponding?	N/A
Yes	Refuge 2 Width (In)	95.0	N/A	Gutter 2 Lip Ht (In)	N/A
Yes	Refuge 2 Slope (%)	4.0	N/A	Gutter 2 Slope (%)	N/A
Yes	Refuge 2 X Slope (%)	2.1	N/A	Gutter 2 X Slope (%)	N/A
N/A	Painted X Walk2?	Yes	N/A	DWS 2 Provided?	N/A
N/A	X Walk 2 Direction	To S	N/A	DWS 2 Contrast?	N/A
N/A	X Walk 2 Width (In)	104.0	N/A	DWS 2 Length (In)	N/A

N/A	Road 2 Slope (%)	0.5	N/A	DWS 2 Full Width?	N/A
N/A	Road 2 X Slope (%)	2.1	N/A	DWS 2 Offset (In)	N/A
N/A	Refuge 3 Length (in)	N/A	N/A	Gutter 3 Ponding?	N/A
N/A	Refuge 3 Width (in)	N/A	N/A	Gutter 3 Lip Ht (in)	N/A
N/A	Refuge 3 Slope (%)	N/A	N/A	Gutter 3 Slope (%)	N/A
N/A	Refuge 3 XSlope (%)	N/A	N/A	Gutter 3 XSlope (%)	N/A
N/A	Painted X Walk3?	N/A	N/A	DWS 3 Provided?	N/A
N/A	X Walk 3 Direction	N/A	N/A	DWS 3 Contrast?	N/A
N/A	X Walk 3 Width (in)	N/A	N/A	DWS 3 Length (in)	N/A
N/A	Road 3 Slope (%)	N/A	N/A	DWS 3 Full Width?	N/A
N/A	Road 3 XSlope (%)	N/A	N/A	DWS 3 Offset (in)	N/A
Yes	Any Obstructions?	N/A	N/A	Storm Grate/Utility Hazard?	N/A
N/A	Obstruction Type		N/A	Storm Grate/Utility Type	
		N/A			N/A
N/A	Surface Condition	Good

Remove & Replace Entire Refuge.
