# Access Compliance Report

## Public Rights-of-Way

### (Island Curb Cuts)

Intersection ID: 25705	Main Street: REA_RD	Cross Street: SUNDANCER_LN	Location:	N
ADA ID: E2E006115FC0	Curb Cut Type: MedianRefuge2	Initial Pass/Fail: Fail	Overall Compliance: No	Severity Score: 0
Codes/Mitigation Info/Possible Solution		Field Measurements/Component Compliance

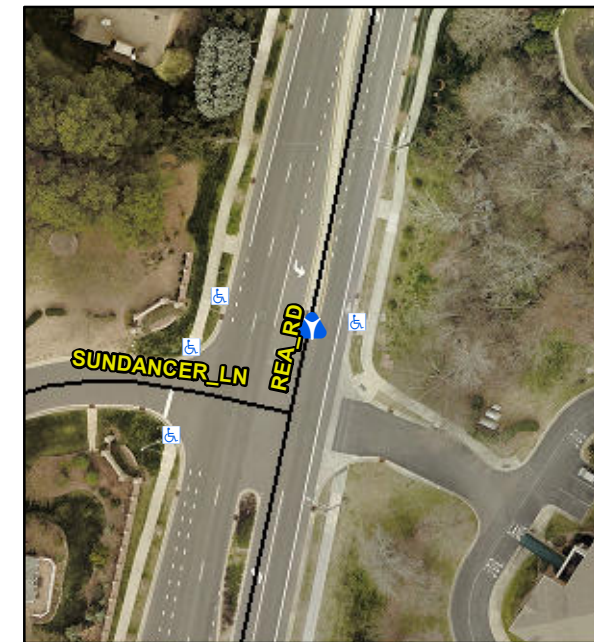
Compliance	Description	Data	Compliance	Description	Data
Yes	Refuge 1 Length (In)	39.5	N/A	Gutter 1 Ponding?	N/A
Yes	Refuge 1 Width (In)	97.0	N/A	Gutter 1 Lip Ht (In)	N/A
Yes	Refuge 1 Slope (%)	1.9	N/A	Gutter 1 Slope (%)	N/A
Yes	Refuge 1 X Slope (%)	3.3	N/A	Gutter 1 X Slope (%)	N/A
N/A	Painted X Walk1?	No	N/A	DWS 1 Provided?	N/A
N/A	X Walk 1 Direction	To W	N/A	DWS 1 Contrast?	N/A
N/A	X Walk 1 Width (In)	N/A	N/A	DWS 1 Length (In)	N/A
N/A	Road 1 Slope (%)	2.6	N/A	DWS 1 Full Width?	N/A
N/A	Road 1 X Slope (%)	2.8	N/A	DWS 1 Offset (In)	N/A
Yes	Refuge 2 Length (In)	39.5	N/A	Gutter 2 Ponding?	N/A
Yes	Refuge 2 Width (In)	97.0	N/A	Gutter 2 Lip Ht (In)	N/A
Yes	Refuge 2 Slope (%)	1.2	N/A	Gutter 2 Slope (%)	N/A
Yes	Refuge 2 X Slope (%)	2.4	N/A	Gutter 2 X Slope (%)	N/A
N/A	Painted X Walk2?	No	N/A	DWS 2 Provided?	N/A
N/A	X Walk 2 Direction	To E	N/A	DWS 2 Contrast?	N/A
N/A	X Walk 2 Width (In)	N/A	N/A	DWS 2 Length (In)	N/A

N/A	Road 2 Slope (%)	3.2	N/A	DWS 2 Full Width?	N/A
N/A	Road 2 X Slope (%)	3.4	N/A	DWS 2 Offset (In)	N/A
N/A	Refuge 3 Length (in)	N/A	N/A	Gutter 3 Ponding?	N/A
N/A	Refuge 3 Width (in)	N/A	N/A	Gutter 3 Lip Ht (in)	N/A
N/A	Refuge 3 Slope (%)	N/A	N/A	Gutter 3 Slope (%)	N/A
N/A	Refuge 3 XSlope (%)	N/A	N/A	Gutter 3 XSlope (%)	N/A
N/A	Painted X Walk3?	N/A	N/A	DWS 3 Provided?	N/A
N/A	X Walk 3 Direction	N/A	N/A	DWS 3 Contrast?	N/A
N/A	X Walk 3 Width (in)	N/A	N/A	DWS 3 Length (in)	N/A
N/A	Road 3 Slope (%)	N/A	N/A	DWS 3 Full Width?	N/A
N/A	Road 3 XSlope (%)	N/A	N/A	DWS 3 Offset (in)	N/A
Yes	Any Obstructions?	N/A	N/A	Storm Grate/Utility Hazard?	N/A
N/A	Obstruction Type		N/A	Storm Grate/Utility Type	
		N/A			N/A
N/A	Surface Condition	Good

**Remove & Replace Entire Refuge.**

**\$ 3000.00**
