Access Compliance Report

Public Rights-of-Way

(Island Curb Cuts)

Intersection ID: 8626	Main Street: N_TRYON_ST	Cross Street: NORTHCHASE_DR	Location: NW
ADA ID: E363688C25B3	Curb Cut Type: MedianRefuge2	Initial Pass/Fail: Fail	Overall Compliance: No
Severity Score: 33.75			
Codes/Mitigation Info/Possible Solution		Field Measurements/Component Compliance

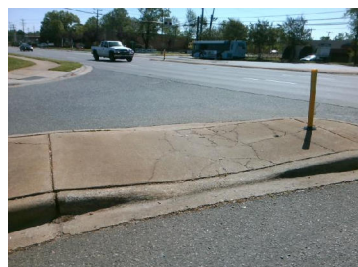
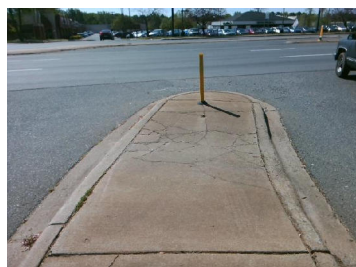
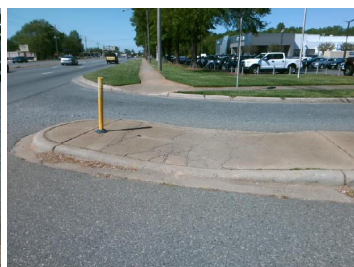
Compliance	Description	Data	Compliance	Description	Data
No	Refuge 1 Length (In)	34.5	N/A	Gutter 1 Ponding?	N/A
No	Refuge 1 Width (In)	38.0	N/A	Gutter 1 Lip Ht (In)	N/A
Yes	Refuge 1 Slope (%)	2.1	N/A	Gutter 1 Slope (%)	N/A
Yes	Refuge 1 X Slope (%)	0.1	N/A	Gutter 1 X Slope (%)	N/A
N/A	Painted X Walk1?	No	N/A	DWS 1 Provided?	N/A
N/A	X Walk 1 Direction	To E	N/A	DWS 1 Contrast?	N/A
N/A	X Walk 1 Width (In)	N/A	N/A	DWS 1 Length (In)	N/A
N/A	Road 1 Slope (%)	1.4	N/A	DWS 1 Full Width?	N/A
N/A	Road 1 X Slope (%)	1.3	N/A	DWS 1 Offset (In)	N/A
No	Refuge 2 Length (In)	34.5	N/A	Gutter 2 Ponding?	N/A
No	Refuge 2 Width (In)	38.0	N/A	Gutter 2 Lip Ht (In)	N/A
Yes	Refuge 2 Slope (%)	2.2	N/A	Gutter 2 Slope (%)	N/A
Yes	Refuge 2 X Slope (%)	0.2	N/A	Gutter 2 X Slope (%)	N/A
N/A	Painted X Walk2?	No	N/A	DWS 2 Provided?	N/A
N/A	X Walk 2 Direction	To W	N/A	DWS 2 Contrast?	N/A
N/A	X Walk 2 Width (In)	N/A	N/A	DWS 2 Length (In)	N/A
N/A	Road 2 Slope (%)	1.2	N/A	DWS 2 Full Width?	N/A

N/A	Road 2 X Slope (%)	1.9	N/A	DWS 2 Offset (In)	N/A
N/A	Refuge 3 Length (in)	N/A	N/A	Gutter 3 Ponding?	N/A
N/A	Refuge 3 Width (in)	N/A	N/A	Gutter 3 Lip Ht (in)	N/A
N/A	Refuge 3 Slope (%)	N/A	N/A	Gutter 3 Slope (%)	N/A
N/A	Refuge 3 XSlope (%)	N/A	N/A	Gutter 3 XSlope (%)	N/A
N/A	Painted X Walk3?	N/A	N/A	DWS 3 Provided?	N/A
N/A	X Walk 3 Direction	N/A	N/A	DWS 3 Contrast?	N/A
N/A	X Walk 3 Width (in)	N/A	N/A	DWS 3 Length (in)	N/A
N/A	Road 3 Slope (%)	N/A	N/A	DWS 3 Full Width?	N/A
N/A	Road 3 XSlope (%)	N/A	N/A	DWS 3 Offset (in)	N/A
Yes	Any Obstructions?	N/A	N/A	Storm Grate/Utility Hazard?	N/A
N/A	Obstruction Type		N/A	Storm Grate/Utility Type	
		N/A			N/A
No	Surface Condition	Poor

Remove & Replace Entire Refuge.
