# Access Compliance Report

## Public Rights-of-Way

### (Island Curb Cuts)

Intersection ID: 10038783	Main Street: STEELE_CREEK_RD	Cross Street: N/A	Location: E
ADA ID: E7272BF5BF9B	Curb Cut Type: MedianRefuge2	Initial Pass/Fail: Fail	Overall Compliance: No
Codes/Mitigation Info/Possible Solution		Field Measurements/Component Compliance	
Severity Score: 10

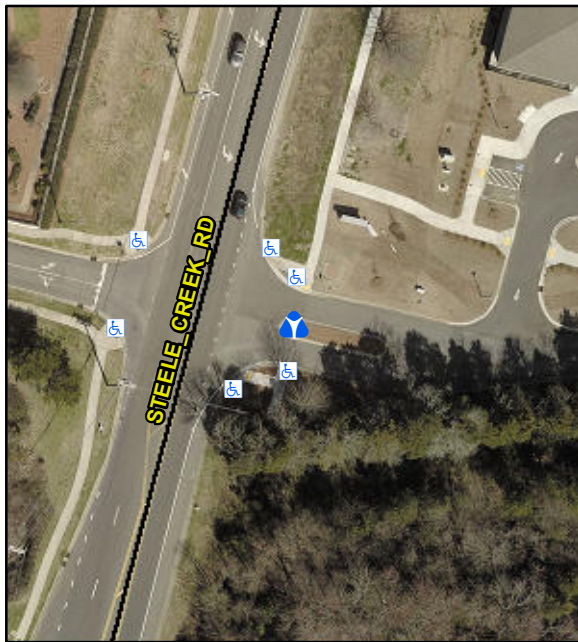
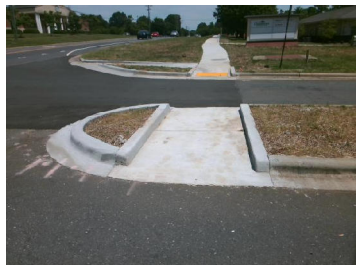
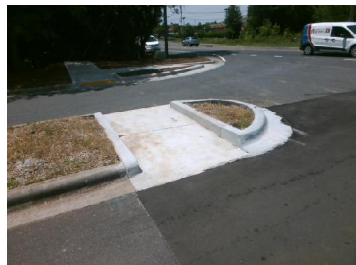
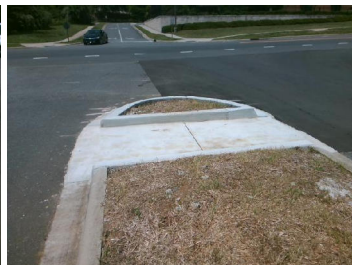
Compliance	Description	Data	Compliance	Description	Data
Yes	Refuge 1 Length (In)	56.0	N/A	Gutter 1 Ponding?	N/A
No	Refuge 1 Width (In)	59.0	N/A	Gutter 1 Lip Ht (In)	N/A
Yes	Refuge 1 Slope (%)	1.5	N/A	Gutter 1 Slope (%)	N/A
Yes	Refuge 1 X Slope (%)	2.5	N/A	Gutter 1 X Slope (%)	N/A
N/A	Painted X Walk1?	No	N/A	DWS 1 Provided?	N/A
N/A	X Walk 1 Direction	To S	N/A	DWS 1 Contrast?	N/A
N/A	X Walk 1 Width (In)	N/A	N/A	DWS 1 Length (In)	N/A
N/A	Road 1 Slope (%)	3.3	N/A	DWS 1 Full Width?	N/A
N/A	Road 1 X Slope (%)	1.1	N/A	DWS 1 Offset (In)	N/A
Yes	Refuge 2 Length (In)	56.0	N/A	Gutter 2 Ponding?	N/A
No	Refuge 2 Width (In)	59.0	N/A	Gutter 2 Lip Ht (In)	N/A
Yes	Refuge 2 Slope (%)	2.2	N/A	Gutter 2 Slope (%)	N/A
Yes	Refuge 2 X Slope (%)	1.2	N/A	Gutter 2 X Slope (%)	N/A
N/A	Painted X Walk2?	No	N/A	DWS 2 Provided?	N/A
N/A	X Walk 2 Direction	To N	N/A	DWS 2 Contrast?	N/A
N/A	X Walk 2 Width (In)	N/A	N/A	DWS 2 Length (In)	N/A

**Remove & Replace Entire Refuge.**
