# Access Compliance Report

## Public Rights-of-Way

### (Island Curb Cuts)

| Intersection ID: 5935 | Main Street: MALLARD_CREEK_RD | Cross Street: W_SUGAR_CREEK_RD | Location: NE |

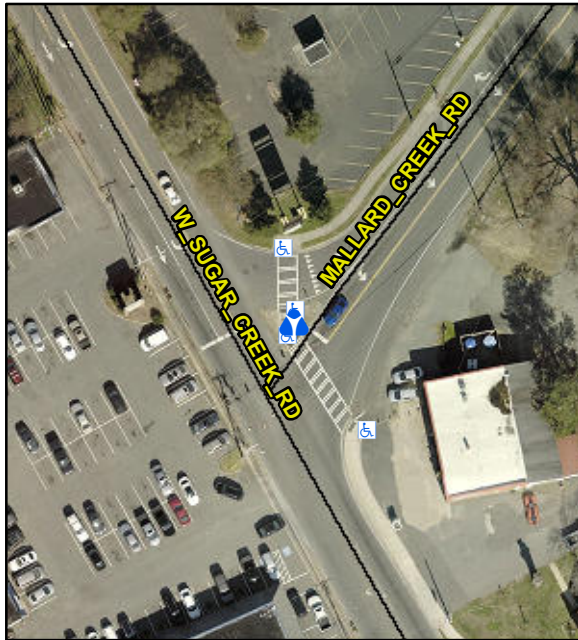
| Compliance | Description | Data | Compliance | Description | Data |
|---|---|---|---|---|---|
| Yes | Refuge 2 Slope (%) | 3.0 | No | Gutter 2 Slope (%) | 8.8 |
| Yes | Refuge 2 X Slope (%) | 1.1 | No | Gutter 2 X Slope (%) | 2.3 |

Possible Solutions:

**Remove & Replace Gutter.**

Total Cost: \$ 750.00
