Access Compliance Report

Public Rights-of-Way

(Island Curb Cuts)

Intersection ID: 10020275	Main Street: AYRSLEY_TOWN_BV	Cross Street: N/A	Location: E
ADA ID: EE935F2AA980	Curb Cut Type: MedianRefuge2	Initial Pass/Fail: Fail	Overall Compliance: No
Codes/Mitigation Info/Possible Solution		Field Measurements/Component Compliance

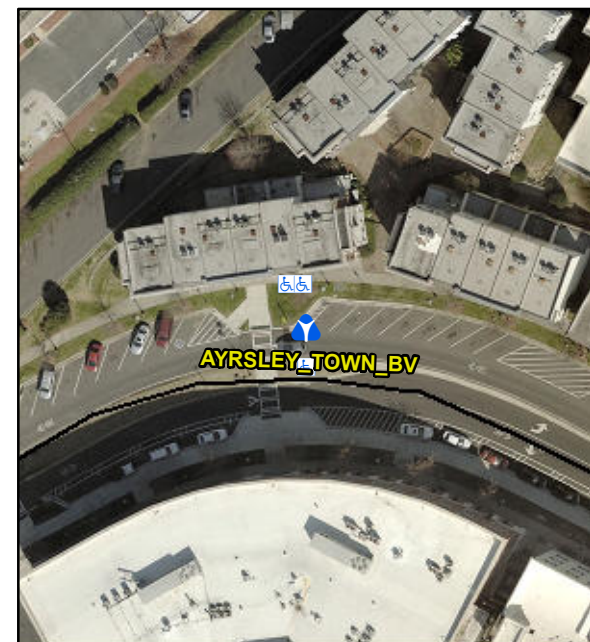
Compliance	Description	Data	Compliance	Description	Data
Yes	Refuge 1 Length (In)	78.0	N/A	Gutter 1 Ponding?	N/A
Yes	Refuge 1 Width (In)	119.0	N/A	Gutter 1 Lip Ht (In)	N/A
Yes	Refuge 1 Slope (%)	0.5	N/A	Gutter 1 Slope (%)	N/A
Yes	Refuge 1 X Slope (%)	4.1	N/A	Gutter 1 X Slope (%)	N/A
N/A	Painted X Walk1?	Yes	N/A	DWS 1 Provided?	N/A
N/A	X Walk 1 Direction	To N	N/A	DWS 1 Contrast?	N/A
N/A	X Walk 1 Width (In)	104.0	N/A	DWS 1 Length (In)	N/A
N/A	Road 1 Slope (%)	2.6	N/A	DWS 1 Full Width?	N/A
N/A	Road 1 X Slope (%)	1.2	N/A	DWS 1 Offset (In)	N/A
Yes	Refuge 2 Length (In)	78.0	N/A	Gutter 2 Ponding?	N/A
Yes	Refuge 2 Width (In)	119.0	N/A	Gutter 2 Lip Ht (In)	N/A
Yes	Refuge 2 Slope (%)	1.7	N/A	Gutter 2 Slope (%)	N/A
Yes	Refuge 2 X Slope (%)	4.0	N/A	Gutter 2 X Slope (%)	N/A
N/A	Painted X Walk2?	Yes	N/A	DWS 2 Provided?	N/A
N/A	X Walk 2 Direction	To S	N/A	DWS 2 Contrast?	N/A
N/A	X Walk 2 Width (In)	104.0	N/A	DWS 2 Length (In)	N/A

N/A	Road 2 Slope (%)	2.2	N/A	DWS 2 Full Width?	N/A
N/A	Road 2 X Slope (%)	1.8	N/A	DWS 2 Offset (In)	N/A
N/A	Refuge 3 Length (in)	N/A	N/A	Gutter 3 Ponding?	N/A
N/A	Refuge 3 Width (in)	N/A	N/A	Gutter 3 Lip Ht (in)	N/A
N/A	Refuge 3 Slope (%)	N/A	N/A	Gutter 3 Slope (%)	N/A
N/A	Refuge 3 XSlope (%)	N/A	N/A	Gutter 3 XSlope (%)	N/A
N/A	Painted X Walk3?	N/A	N/A	DWS 3 Provided?	N/A
N/A	X Walk 3 Direction	N/A	N/A	DWS 3 Contrast?	N/A
N/A	X Walk 3 Width (in)	N/A	N/A	DWS 3 Length (in)	N/A
N/A	Road 3 Slope (%)	N/A	N/A	DWS 3 Full Width?	N/A
N/A	Road 3 XSlope (%)	N/A	N/A	DWS 3 Offset (in)	N/A
Yes	Any Obstructions?	N/A	N/A	Storm Grate/Utility Hazard?	N/A
N/A	Obstruction Type		N/A	Storm Grate/Utility Type	
		N/A			N/A
N/A	Surface Condition	Good

Remove & Replace Entire Refuge.
