# Access Compliance Report

## Public Rights-of-Way

### (Island Curb Cuts)

Intersection ID: 27988	Main Street: JOHNSTON_RD	Cross Street: PROVIDENCE_RD_WEST	Location: NW
ADA ID: F2748CBCCF43	Curb Cut Type: IslandRefuge3	Initial Pass/Fail: Fail	Overall Compliance: No
Severity Score: 36.25			
Codes/Mitigation Info/Possible Solution		Field Measurements/Component Compliance

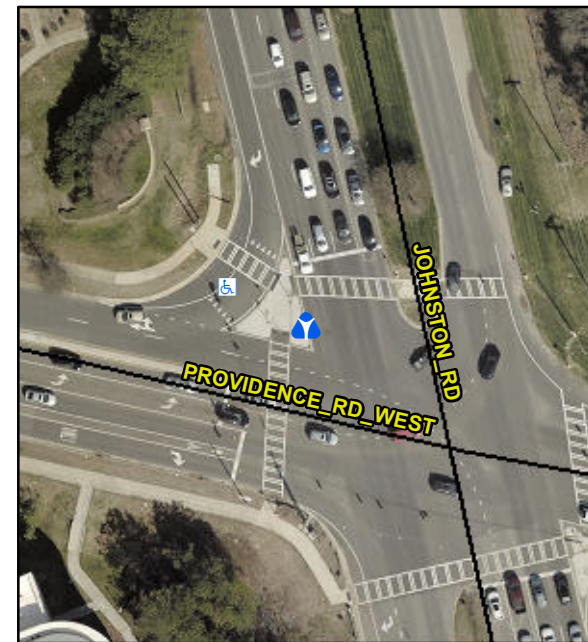
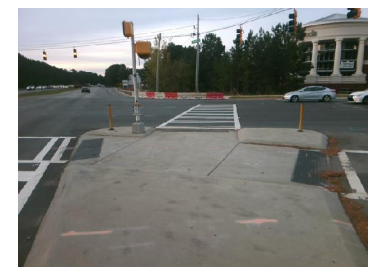
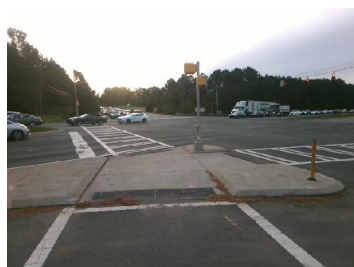
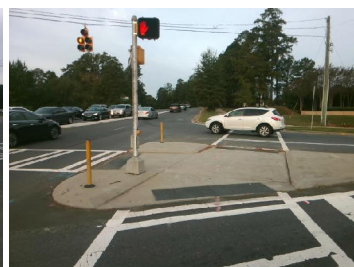
Compliance	Description	Data	Compliance	Description	Data
Yes	Refuge 1 Length (In)	84.0	N/A	Gutter 1 Ponding?	N/A
Yes	Refuge 1 Width (In)	117.0	N/A	Gutter 1 Lip Ht (In)	N/A
Yes	Refuge 1 Slope (%)	3.1	N/A	Gutter 1 Slope (%)	N/A
Yes	Refuge 1 X Slope (%)	0.1	N/A	Gutter 1 X Slope (%)	N/A
N/A	Painted X Walk1?	Yes	N/A	DWS 1 Provided?	N/A
N/A	X Walk 1 Direction	To W	N/A	DWS 1 Contrast?	N/A
N/A	X Walk 1 Width (In)	127.0	N/A	DWS 1 Length (In)	N/A
N/A	Road 1 Slope (%)	0.3	N/A	DWS 1 Full Width?	N/A
N/A	Road 1 X Slope (%)	1.1	N/A	DWS 1 Offset (In)	N/A
Yes	Refuge 2 Length (In)	96.0	N/A	Gutter 2 Ponding?	N/A
Yes	Refuge 2 Width (In)	120.0	N/A	Gutter 2 Lip Ht (In)	N/A
Yes	Refuge 2 Slope (%)	2.7	N/A	Gutter 2 Slope (%)	N/A
Yes	Refuge 2 X Slope (%)	0.0	N/A	Gutter 2 X Slope (%)	N/A
N/A	Painted X Walk2?	Yes	N/A	DWS 2 Provided?	N/A
N/A	X Walk 2 Direction	To E	N/A	DWS 2 Contrast?	N/A
N/A	X Walk 2 Width (In)	128.0	N/A	DWS 2 Length (In)	N/A

N/A	Road 2 Slope (%)	0.8	N/A	DWS 2 Full Width?	N/A
N/A	Road 2 X Slope (%)	1.2	N/A	DWS 2 Offset (In)	N/A
Yes	Refuge 3 Length (in)	93.5	N/A	Gutter 3 Ponding?	N/A
Yes	Refuge 3 Width (in)	119.0	N/A	Gutter 3 Lip Ht (in)	N/A
Yes	Refuge 3 Slope (%)	3.3	N/A	Gutter 3 Slope (%)	N/A
Yes	Refuge 3 XSlope (%)	2.4	N/A	Gutter 3 XSlope (%)	N/A
N/A	Painted X Walk3?	Yes	N/A	DWS 3 Provided?	N/A
N/A	X Walk 3 Direction	To S	N/A	DWS 3 Contrast?	N/A
N/A	X Walk 3 Width (in)	131.0	N/A	DWS 3 Length (in)	N/A
N/A	Road 3 Slope (%)	0.2	N/A	DWS 3 Full Width?	N/A
N/A	Road 3 XSlope (%)	0.6	N/A	DWS 3 Offset (in)	N/A
Yes	Any Obstructions?	N/A	N/A	Storm Grate/Utility Hazard?	N/A
N/A	Obstruction Type		N/A	Storm Grate/Utility Type	
			N/A		N/A
N/A	Surface Condition	Good

**Remove & Replace Entire Refuge.**

**\$ 3000.00**
