# Access Compliance Report

## Public Rights-of-Way

### (Island Curb Cuts)

Intersection ID: 10936	Main Street: LITTLE ROCK RD	Cross Street: SCOTT FUTRELL DR	Location: NE
ADA ID: F61150205056	Curb Cut Type: IslandRefuge3	Initial Pass/Fail: Fail	Overall Compliance: No
Severity Score: 36.25			
Codes/Mitigation Info/Possible Solution		Field Measurements/Component Compliance

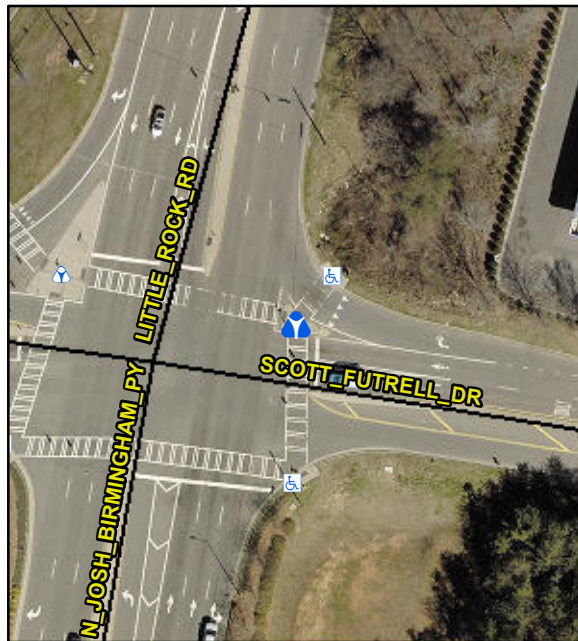
Compliance	Description	Data	Compliance	Description	Data
No	Refuge 1 Length (In)	71.0	N/A	Gutter 1 Ponding?	N/A
Yes	Refuge 1 Width (In)	70.0	N/A	Gutter 1 Lip Ht (In)	N/A
Yes	Refuge 1 Slope (%)	2.8	N/A	Gutter 1 Slope (%)	N/A
Yes	Refuge 1 X Slope (%)	1.3	N/A	Gutter 1 X Slope (%)	N/A
N/A	Painted X Walk1?	Yes	N/A	DWS 1 Provided?	N/A
N/A	X Walk 1 Direction	To W	N/A	DWS 1 Contrast?	N/A
N/A	X Walk 1 Width (In)	113.0	N/A	DWS 1 Length (In)	N/A
N/A	Road 1 Slope (%)	1.7	N/A	DWS 1 Full Width?	N/A
N/A	Road 1 X Slope (%)	3.1	N/A	DWS 1 Offset (In)	N/A
No	Refuge 2 Length (In)	39.0	N/A	Gutter 2 Ponding?	N/A
Yes	Refuge 2 Width (In)	74.0	N/A	Gutter 2 Lip Ht (In)	N/A
Yes	Refuge 2 Slope (%)	0.9	N/A	Gutter 2 Slope (%)	N/A
Yes	Refuge 2 X Slope (%)	3.5	N/A	Gutter 2 X Slope (%)	N/A
N/A	Painted X Walk2?	Yes	N/A	DWS 2 Provided?	N/A
N/A	X Walk 2 Direction	To S	N/A	DWS 2 Contrast?	N/A
N/A	X Walk 2 Width (In)	113.0	N/A	DWS 2 Length (In)	N/A

N/A	Road 2 Slope (%)	2.8	N/A	DWS 2 Full Width?	N/A
N/A	Road 2 X Slope (%)	1.0	N/A	DWS 2 Offset (In)	N/A
No	Refuge 3 Length (in)	25.0	N/A	Gutter 3 Ponding?	N/A
Yes	Refuge 3 Width (in)	92.0	N/A	Gutter 3 Lip Ht (in)	N/A
Yes	Refuge 3 Slope (%)	0.8	N/A	Gutter 3 Slope (%)	N/A
Yes	Refuge 3 XSlope (%)	4.2	N/A	Gutter 3 XSlope (%)	N/A
N/A	Painted X Walk3?	Yes	N/A	DWS 3 Provided?	N/A
N/A	X Walk 3 Direction	To NE	N/A	DWS 3 Contrast?	N/A
N/A	X Walk 3 Width (in)	113.0	N/A	DWS 3 Length (in)	N/A
N/A	Road 3 Slope (%)	2.9	N/A	DWS 3 Full Width?	N/A
N/A	Road 3 XSlope (%)	1.7	N/A	DWS 3 Offset (in)	N/A
Yes	Any Obstructions?	N/A	N/A	Storm Grate/Utility Hazard?	N/A
N/A	Obstruction Type		N/A	Storm Grate/Utility Type	
		N/A			N/A
N/A	Surface Condition	Good

**Remove & Replace Entire Refuge.**

Total Cost: \$ 3000.00
