# Access Compliance Report

## Public Rights-of-Way

### (Island Curb Cuts)

Intersection ID: 10037397	Main Street: SCALEYBARK_RD	Cross Street: N/A	Location: N/A
ADA ID: F6117C2F4DEE	Curb Cut Type: MedianRefuge2	Initial Pass/Fail: Fail	Overall Compliance: No
Codes/Mitigation Info/Possible Solution		Field Measurements/Component Compliance

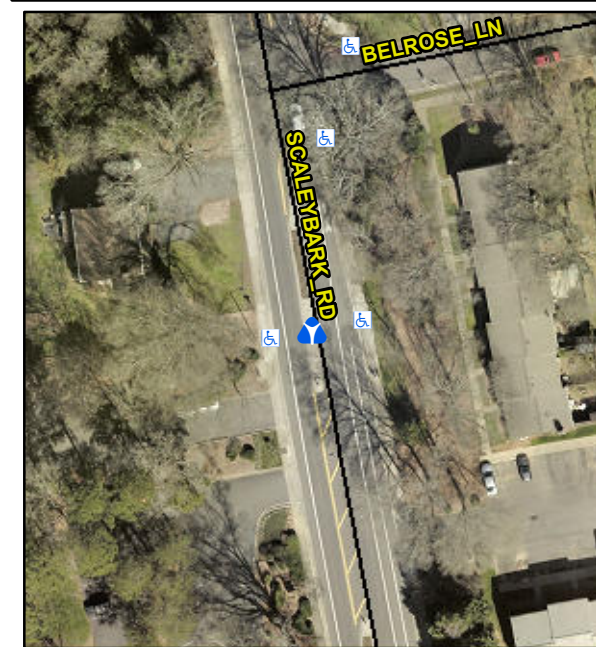
Compliance	Description	Data	Compliance	Description	Data
No	Refuge 1 Length (In)	20.5	N/A	Gutter 1 Ponding?	N/A
No	Refuge 1 Width (In)	59.0	N/A	Gutter 1 Lip Ht (In)	N/A
No	Refuge 1 Slope (%)	5.5	N/A	Gutter 1 Slope (%)	N/A
Yes	Refuge 1 X Slope (%)	2.6	N/A	Gutter 1 X Slope (%)	N/A
N/A	Painted X Walk1?	No	N/A	DWS 1 Provided?	N/A
N/A	X Walk 1 Direction	To W	N/A	DWS 1 Contrast?	N/A
N/A	X Walk 1 Width (In)	N/A	N/A	DWS 1 Length (In)	N/A
N/A	Road 1 Slope (%)	3.2	N/A	DWS 1 Full Width?	N/A
N/A	Road 1 X Slope (%)	1.4	N/A	DWS 1 Offset (In)	N/A
No	Refuge 2 Length (In)	20.5	N/A	Gutter 2 Ponding?	N/A
No	Refuge 2 Width (In)	59.0	N/A	Gutter 2 Lip Ht (In)	N/A
Yes	Refuge 2 Slope (%)	1.4	N/A	Gutter 2 Slope (%)	N/A
Yes	Refuge 2 X Slope (%)	3.4	N/A	Gutter 2 X Slope (%)	N/A
N/A	Painted X Walk2?	No	N/A	DWS 2 Provided?	N/A
N/A	X Walk 2 Direction	To E	N/A	DWS 2 Contrast?	N/A
N/A	X Walk 2 Width (In)	N/A	N/A	DWS 2 Length (In)	N/A
N/A	Road 2 Slope (%)	2.8	N/A	DWS 2 Full Width?	N/A

N/A	Road 2 X Slope (%)	1.5	N/A	DWS 2 Offset (In)	N/A
N/A	Refuge 3 Length (in)	N/A	N/A	Gutter 3 Ponding?	N/A
N/A	Refuge 3 Width (in)	N/A	N/A	Gutter 3 Lip Ht (in)	N/A
N/A	Refuge 3 Slope (%)	N/A	N/A	Gutter 3 Slope (%)	N/A
N/A	Refuge 3 XSlope (%)	N/A	N/A	Gutter 3 XSlope (%)	N/A
N/A	Painted X Walk3?	N/A	N/A	DWS 3 Provided?	N/A
N/A	X Walk 3 Direction	N/A	N/A	DWS 3 Contrast?	N/A
N/A	X Walk 3 Width (in)	N/A	N/A	DWS 3 Length (in)	N/A
N/A	Road 3 Slope (%)	N/A	N/A	DWS 3 Full Width?	N/A
N/A	Road 3 XSlope (%)	N/A	N/A	DWS 3 Offset (in)	N/A
Yes	Any Obstructions?	N/A	N/A	Storm Grate/Utility Hazard?	N/A
N/A	Obstruction Type		N/A	Storm Grate/Utility Type	
		N/A			N/A
N/A	Surface Condition	Good

**Remove & Replace Entire Refuge.**

Total Cost: \$ 3000.00
