# Access Compliance Report

## Public Rights-of-Way

### (Island Curb Cuts)

Intersection ID: 5574	Main Street: BANNER_ELK_DR	Cross Street: SUNSET_RD	Location: NW
ADA ID: F7A6AE3CFFFD	Curb Cut Type: MedianRefuge2	Initial Pass/Fail: Pass	Overall Compliance: Yes
Codes/Mitigation Info/Possible Solution		Field Measurements/Component Compliance	
Severity Score: 0

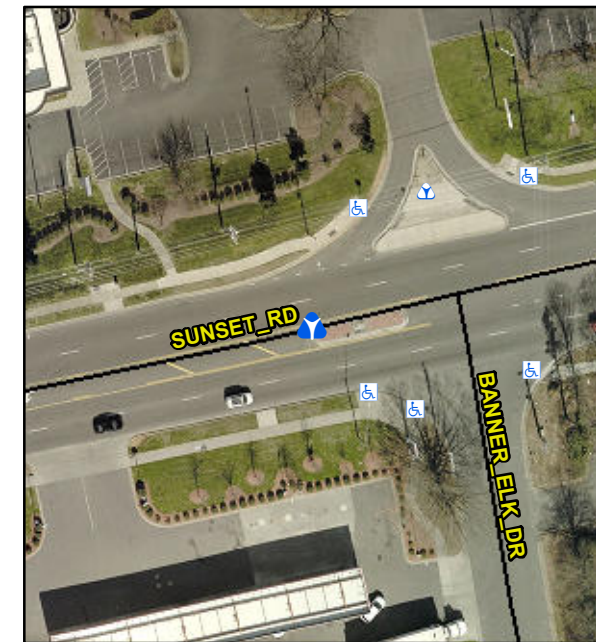
Compliance	Description	Data	Compliance	Description	Data
Yes	Refuge 1 Length (In)	43.0	Yes	Gutter 1 Ponding?	No
Yes	Refuge 1 Width (In)	97.0	Yes	Gutter 1 Lip Ht (In)	0.0
Yes	Refuge 1 Slope (%)	0.7	Yes	Gutter 1 Slope (%)	1.9
Yes	Refuge 1 X Slope (%)	0.0	Yes	Gutter 1 X Slope (%)	0.9
N/A	Painted X Walk1?	No	Yes	DWS 1 Provided?	Yes
N/A	X Walk 1 Direction	To NW	Yes	DWS 1 Contrast?	Yes
N/A	X Walk 1 Width (In)	N/A	Yes	DWS 1 Length (In)	24.0
N/A	Road 1 Slope (%)	0.5	Yes	DWS 1 Full Width?	Yes
N/A	Road 1 X Slope (%)	1.2	Yes	DWS 1 Offset (In)	0.0
Yes	Refuge 2 Length (In)	43.0	Yes	Gutter 2 Ponding?	No
Yes	Refuge 2 Width (In)	97.0	Yes	Gutter 2 Lip Ht (In)	0.0
Yes	Refuge 2 Slope (%)	0.3	Yes	Gutter 2 Slope (%)	1.5
Yes	Refuge 2 X Slope (%)	0.8	Yes	Gutter 2 X Slope (%)	0.1
N/A	Painted X Walk2?	No	Yes	DWS 2 Provided?	Yes
N/A	X Walk 2 Direction	To S	Yes	DWS 2 Contrast?	Yes
N/A	X Walk 2 Width (In)	N/A	Yes	DWS 2 Length (In)	24.0

N/A	Road 2 Slope (%)	4.9	Yes	DWS 2 Full Width?	Yes
N/A	Road 2 X Slope (%)	1.1	Yes	DWS 2 Offset (In)	0.0
N/A	Refuge 3 Length (in)	N/A	N/A	Gutter 3 Ponding?	N/A
N/A	Refuge 3 Width (in)	N/A	N/A	Gutter 3 Lip Ht (in)	N/A
N/A	Refuge 3 Slope (%)	N/A	N/A	Gutter 3 Slope (%)	N/A
N/A	Refuge 3 XSlope (%)	N/A	N/A	Gutter 3 XSlope (%)	N/A
N/A	Painted X Walk3?	N/A	N/A	DWS 3 Provided?	N/A
N/A	X Walk 3 Direction	N/A	N/A	DWS 3 Contrast?	N/A
N/A	X Walk 3 Width (in)	N/A	N/A	DWS 3 Length (in)	N/A
N/A	Road 3 Slope (%)	N/A	N/A	DWS 3 Full Width?	N/A
N/A	Road 3 XSlope (%)	N/A	N/A	DWS 3 Offset (in)	N/A
Yes	Any Obstructions?	No	N/A	Storm Grate/Utility Hazard?	No
N/A	Obstruction Type		N/A	Storm Grate/Utility Type	
N/A	Surface Condition	Good	N/A		N/A

Possible Solutions:

N/A
