# Access Compliance Report

## Public Rights-of-Way

### (Island Curb Cuts)

Intersection ID: 13482	Main Street: ARNOLD_DR	Cross Street: CENTRAL_AV	Location: W
ADA ID: FC5071596170	Curb Cut Type: MedianRefuge2	Initial Pass/Fail: Pass	Overall Compliance: No
Codes/Mitigation Info/Possible Solution		Field Measurements/Component Compliance	
		Severity Score: 15

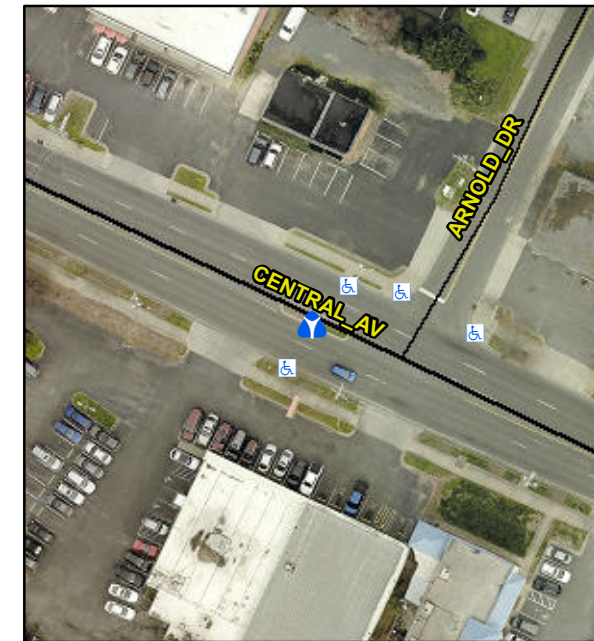
Compliance	Description	Data	Compliance	Description	Data
No	Refuge 1 Length (In)	30.0	N/A	Gutter 1 Ponding?	Yes
Yes	Refuge 1 Width (In)	116.0	N/A	Gutter 1 Lip Ht (In)	N/A
Yes	Refuge 1 Slope (%)	1.0	N/A	Gutter 1 Slope (%)	N/A
Yes	Refuge 1 X Slope (%)	1.2	N/A	Gutter 1 X Slope (%)	N/A
N/A	Painted X Walk1?	No	Yes	DWS 1 Provided?	No
N/A	X Walk 1 Direction	To W	N/A	DWS 1 Contrast?	No
N/A	X Walk 1 Width (In)	N/A	N/A	DWS 1 Length (In)	N/A
N/A	Road 1 Slope (%)	1.6	N/A	DWS 1 Full Width?	No
N/A	Road 1 X Slope (%)	4.0	N/A	DWS 1 Offset (In)	N/A
No	Refuge 2 Length (In)	30.0	N/A	Gutter 2 Ponding?	Yes
Yes	Refuge 2 Width (In)	116.0	N/A	Gutter 2 Lip Ht (In)	N/A
Yes	Refuge 2 Slope (%)	1.0	N/A	Gutter 2 Slope (%)	N/A
Yes	Refuge 2 X Slope (%)	2.0	N/A	Gutter 2 X Slope (%)	N/A
N/A	Painted X Walk2?	No	Yes	DWS 2 Provided?	No
N/A	X Walk 2 Direction	To E	N/A	DWS 2 Contrast?	No
N/A	X Walk 2 Width (In)	N/A	N/A	DWS 2 Length (In)	N/A
N/A	Road 2 Slope (%)	1.3	N/A	DWS 2 Full Width?	No

N/A	Road 2 X Slope (%)	3.8	N/A	DWS 2 Offset (In)	N/A
N/A	Refuge 3 Length (in)	N/A	N/A	Gutter 3 Ponding?	N/A
N/A	Refuge 3 Width (in)	N/A	N/A	Gutter 3 Lip Ht (in)	N/A
N/A	Refuge 3 Slope (%)	N/A	N/A	Gutter 3 Slope (%)	N/A
N/A	Refuge 3 XSlope (%)	N/A	N/A	Gutter 3 XSlope (%)	N/A
N/A	Painted X Walk3?	N/A	N/A	DWS 3 Provided?	N/A
N/A	X Walk 3 Direction	N/A	N/A	DWS 3 Contrast?	N/A
N/A	X Walk 3 Width (in)	N/A	N/A	DWS 3 Length (in)	N/A
N/A	Road 3 Slope (%)	N/A	N/A	DWS 3 Full Width?	N/A
N/A	Road 3 XSlope (%)	N/A	N/A	DWS 3 Offset (in)	N/A
Yes	Any Obstructions?	No	N/A	Storm Grate/Utility Hazard?	No
N/A	Obstruction Type		N/A	Storm Grate/Utility Type	
		N/A			N/A
N/A	Surface Condition	Good

Possible Solutions:

**Remove & Replace Entire Refuge.**

Total Cost: \$ 3000.00
