# Access Compliance Report Public Rights-of-Way (Transit Stops)

| Intersection ID: 10020376 | Main Street: BALLANTYNE_CORPORATE_PL | Cross Street: N/A | Location: E |
| ADA ID: 043F59CA1150 | Overall Compliance: No | Severity Score: 25 | |

CATS Stop Description: **Ballentyne Corporate Pl & Harney Dr**

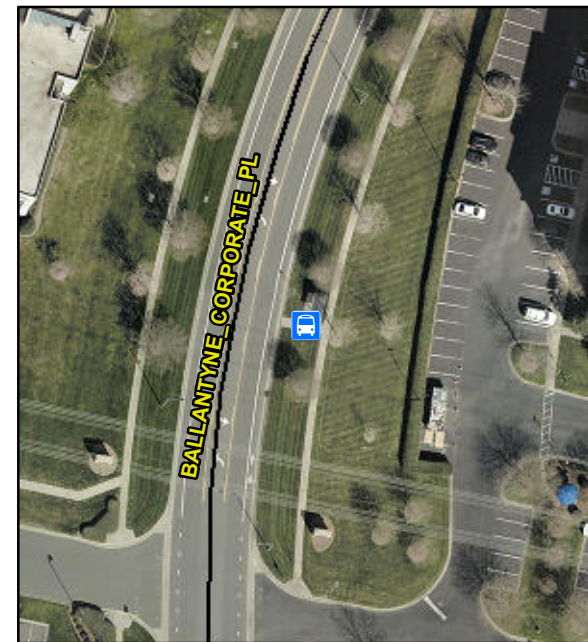
| Compliance | Description | Data |
|---|---|---|
| No | Boarding Area Slope % | 2.1 |
| No | Boarding Area XSlope % | 3.7 |
| No | PAR 1 Slope % | 2.9 |
| No | PAR 1 XSlope % | 2.4 |
| No | PAR 2 Slope % | 2.8 |
| No | Clear Floor Space | Yes |
| No | Clear Floor Space Length (in) | 36.0 |
| No | Clear Floor Space Slope % | 2.2 |
| No | Protruding Objects? | Yes |

**Remove & Replace Boarding Area.  
Remove & Replace Sidewalk To  
Boarding Area. Remove & Replace  
Clear Floor Space. Remove or  
Relocate Protruding  
Objects/Obstructions.**
