# Access Compliance Report Public Rights-of-Way (Transit Stops)

| Intersection ID: 10038366 | Main Street: SOUTH_BV | Cross Street: N/A | Location: W |
| ADA ID: 062B1CC63490 | Overall Compliance: No | Severity Score: 35 | |

CATS Stop Description: South Blvd & Arrowood Rd

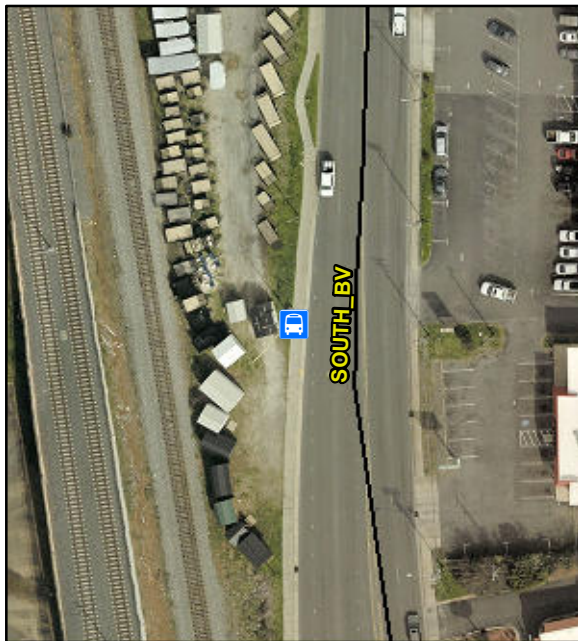
| Compliance | Description | Data |
|---|---|---|
| No | Boarding Area Length (in) | 77.0 |
| No | Protruding Objects? | Yes |

**Remove & Replace Boarding Area.  
Remove or Relocate Protruding  
Objects/Obstructions.**
