# Access Compliance Report Public Rights-of-Way (Transit Stops)

| Intersection ID: 10041341 | Main Street: WEST_BV | Cross Street: N/A | Location: S |
| ADA ID: 0FF740B2C0E7 | Overall Compliance: No | Severity Score: 20 | |

CATS Stop Description: **West Blvd & Old Steele Creek Rd**

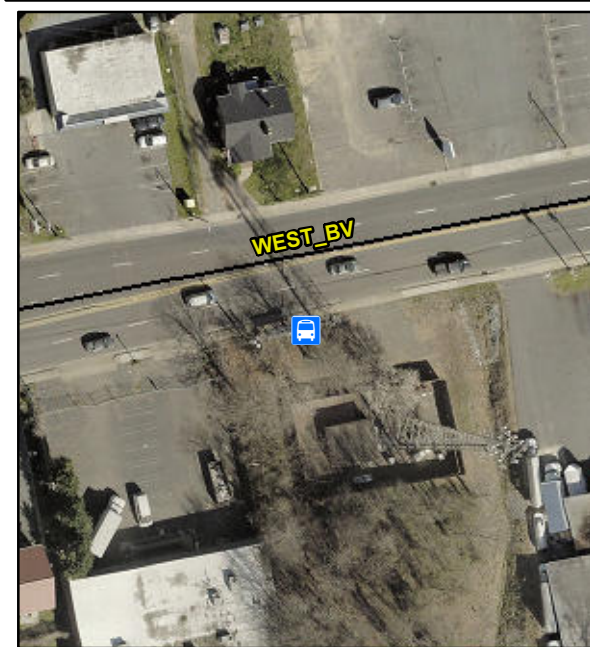
| Codes/Mitigation Info/Possible Solution | Field Measurements/Component Compliance |

| Compliance | Description | Data |
| No | Boarding Area Length (in) | 75.0 |
| No | Boarding Area Slope % | 3.9 |
| No | PAR 1 Width (in) | 47.0 |
| No | PAR 1 XSlope % | 3.8 |
| No | PAR 2 Width (in) | 47.0 |
| No | PAR 2 XSlope % | 3.1 |
| No | Clear Floor Space | Yes |
| No | Clear Floor Space Slope % | 3.2 |
| No | Protruding Objects? | Yes |

Possible Solutions:

**Remove & Replace Boarding Area.  
Remove & Replace Sidewalk To  
Boarding Area. Remove & Replace  
Clear Floor Space. Remove or  
Relocate Protruding  
Objects/Obstructions.**
