# Access Compliance Report Public Rights-of-Way (Transit Stops)

| Intersection ID: 5367 | Main Street: HUBBARD_RD | Cross Street: MALLARD_CREEK_RD | Location: E |
| ADA ID: 109AEDB179B1 | Overall Compliance: No | Severity Score: 75 | |

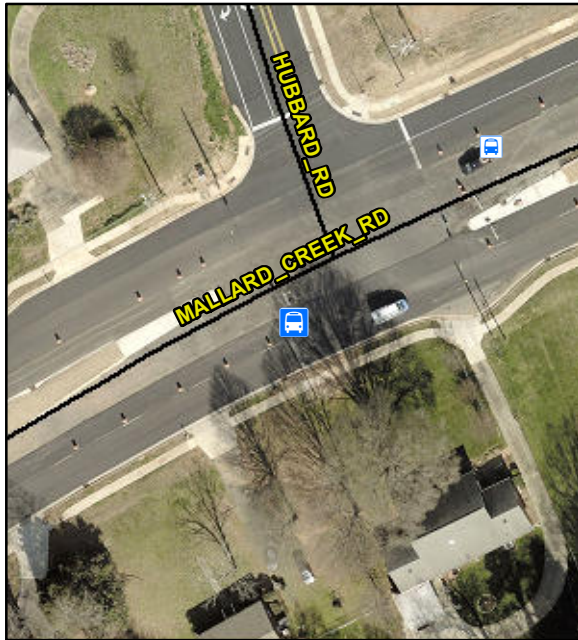
| Compliance | Description | Data |
|---|---|---|
| No | Boarding Area | No |
| No | PAR 1 Exist? | Yes |
| No | PAR 1 XSlope % | 2.1 |
| No | PAR 2 Exist? | Yes |

**Provide Boarding Area. Remove & Replace Sidewalk To Boarding Area. Remove or Relocate Protruding Objects/Obstructions. Adjust Transit Stop Sign Height.**

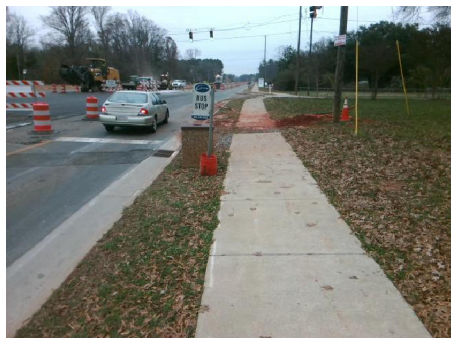
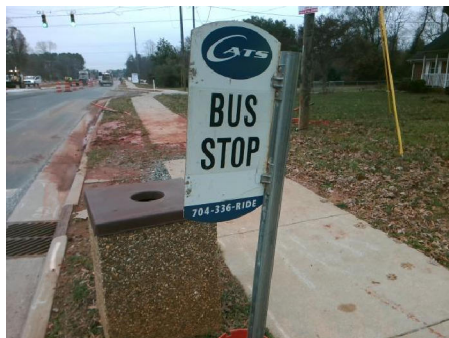
| Compliance | Description | Data |
|---|---|---|
| No | PAR 2 XSlope % | 2.3 |
| No | Boarding Area Connected to PAR? | No |
| No | Transit Sign Height (in) | 39.0 |
| No | Protruding Objects? | Yes |
