# Access Compliance Report Public Rights-of-Way (Transit Stops)

| Intersection ID: 10020889 | Main Street: BELLHAVEN_BV | Cross Street: N/A | Location: S |
| ADA ID: 1AA7BA5D0748 | Overall Compliance: No | Severity Score: 100 | |

CATS Stop Description: Bellhaven Blvd & Brookshire Blvd

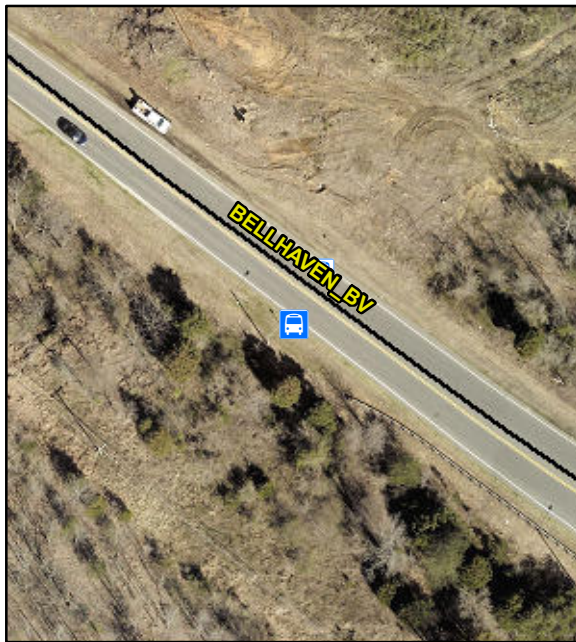
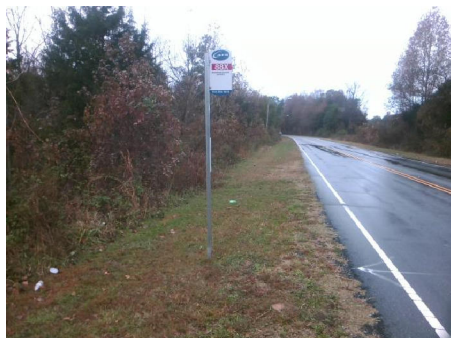
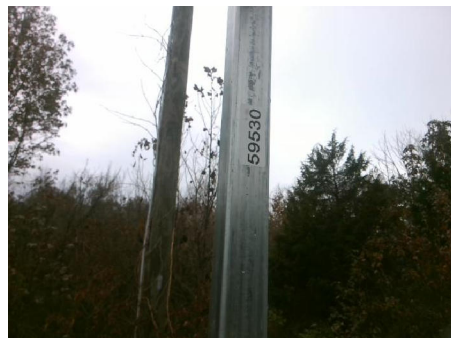
| Compliance | Description | Data |
|---|---|---|
| No | Boarding Area | No |
| No | PAR 1 Exist? | No |
| N/A | Boarding Area Connected to PAR? | No |
| N/A | Road Slope % | 2.5 |
| Yes | Transit Sign? | Yes |
| Yes | Transit Sign Height (in) | 93.0 |

**Provide Boarding Area. Provide Sidewalk To Boarding Area.**

**402.2, 810.2, R302, R308.1.1**
