# Access Compliance Report

## Public Rights-of-Way

### (Transit Stops)

| Intersection ID: 21797 | Main Street: GALLERIA_BV | Cross Street: MONROE_RD | Location: NW |

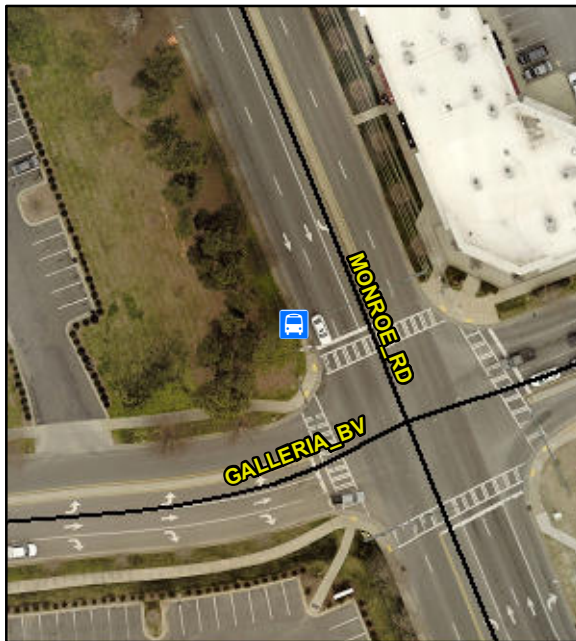
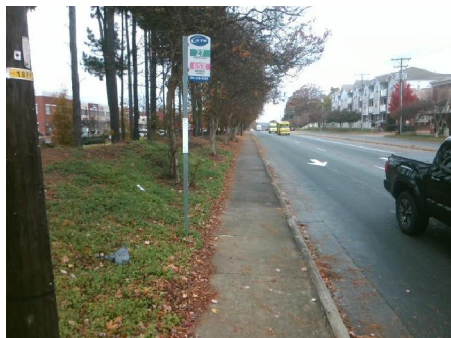
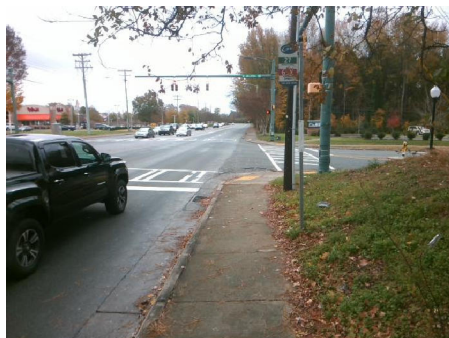
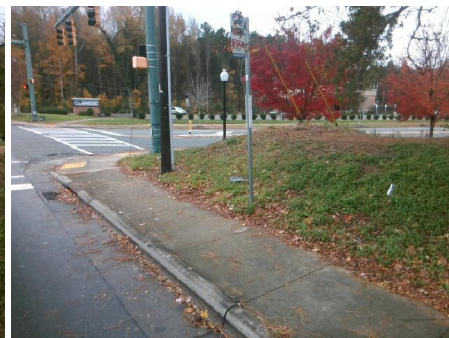
| Compliance | Description | Data |
|---|---|---|
| No | Boarding Area Length (in) | 66.0 |
| No | Boarding Area Slope % | 4.3 |
| No | PAR 1 XSlope % | 4.6 |
| No | PAR 2 Slope % | 3.0 |
| No | PAR 2 XSlope % | 4.8 |

**Remove & Replace Boarding Area.  
Remove & Replace Sidewalk To  
Boarding Area.**
