# Access Compliance Report Public Rights-of-Way (Transit Stops)

| Intersection ID: 10020359 | Main Street: BALLANTYNE_COMMONS_PY | Cross Street: N/A | Location: N |
| ADA ID: 1FB768F9EE68 | Overall Compliance: No | Severity Score: 35 | |

CATS Stop Description: **Ballantyne Commons PI & Johnston Rd**

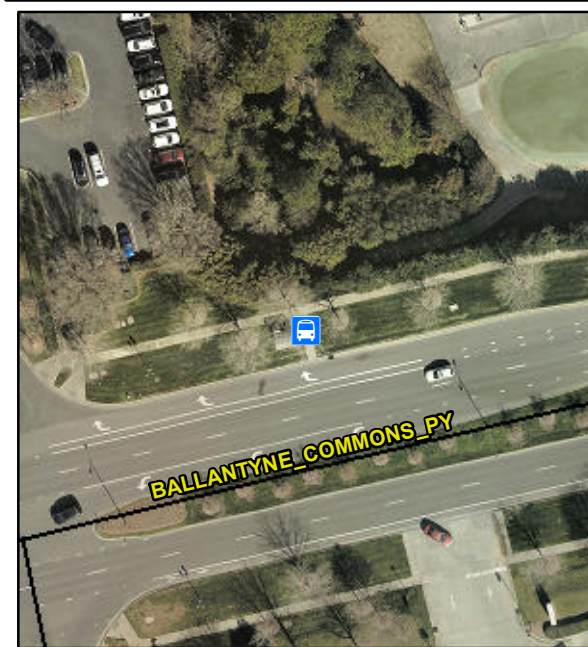
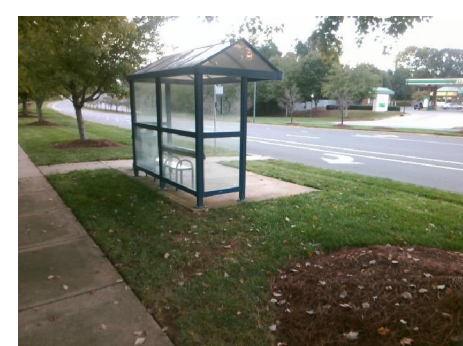
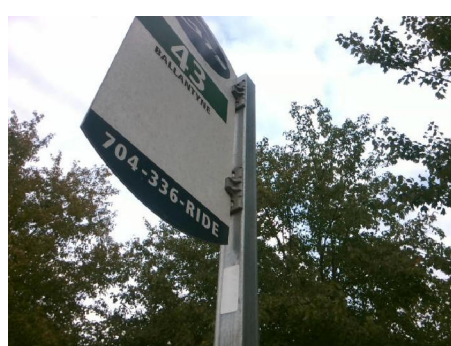
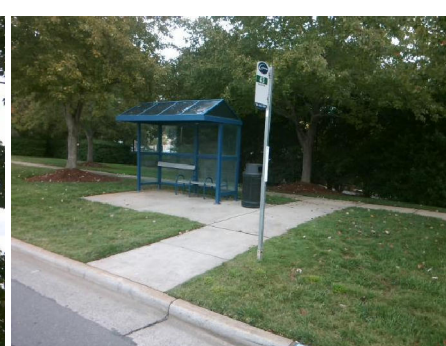
**CATS ID FADED, VERIFIED**

| Compliance | Description | Data |
|---|---|---|
| No | Boarding Area Width (in) | 58.0 |
| No | Boarding Area Slope % | 4.6 |
| No | Boarding Area XSlope % | 2.1 |
| No | PAR 2 Slope % | 2.2 |
| No | PAR 2 XSlope % | 3.2 |
| No | Clear Floor Space Length (in) | 46.0 |
| No | Clear Floor Space Slope % | 2.1 |
| No | Clear Floor Space XSlope % | 2.8 |
| No | Protruding Objects? | Yes |

**Remove & Replace Boarding Area.  
Remove & Replace Sidewalk To  
Boarding Area. Remove & Replace  
Clear Floor Space. Remove or  
Relocate Protruding  
Objects/Obstructions.**
