# Access Compliance Report Public Rights-of-Way (Transit Stops)

| Intersection ID: 10020889 | Main Street: BELLHAVEN_BV | Cross Street: N/A | Location: N |
| ADA ID: 2EF1889A512D | Overall Compliance: No | Severity Score: 100 | |

CATS Stop Description: Bellhaven Blvd & Brookshire Blvd

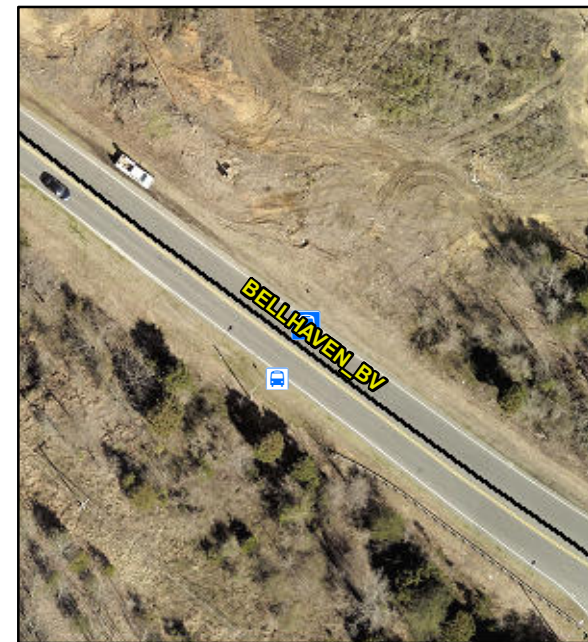
| Compliance | Description | Data |
|---|---|---|
| No | Boarding Area | No |
| No | PAR 1 Exist? | No |
| N/A | Boarding Area Connected to PAR? | No |
| Yes | Transit Sign? | Yes |
| Yes | Transit Sign Height (in) | 93.0 |

**Provide Boarding Area. Provide Sidewalk To Boarding Area.**
