# Access Compliance Report Public Rights-of-Way (Transit Stops)

| Intersection ID: 10031433 | Main Street: MCCLURE_CR | Cross Street: N/A | Location: W |
| ADA ID: 2FEE063C93F9 | Overall Compliance: No | Severity Score: 30 | |

CATS Stop Description: **McClure Cir & Bellhaven Blvd**

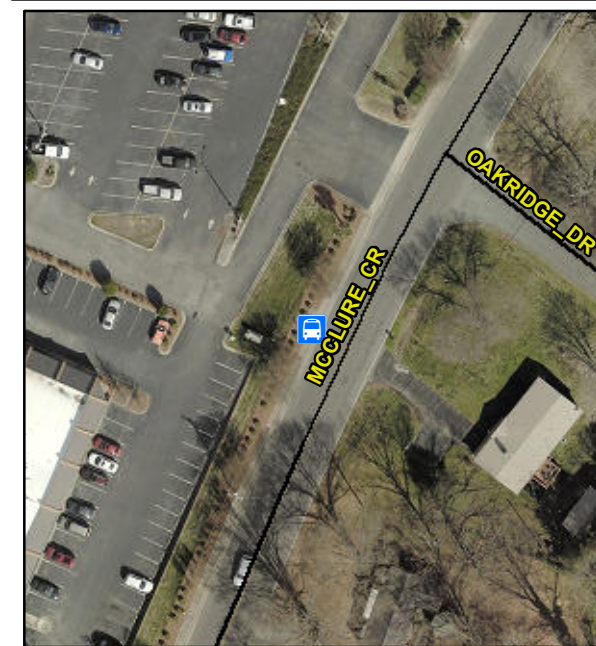
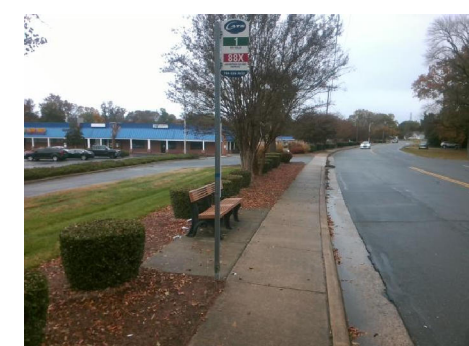
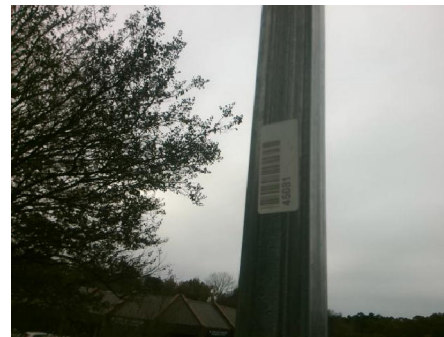
| Compliance | Description | Data |
|---|---|---|
| No | Boarding Area Width (in) | 56.0 |
| No | Boarding Area Slope % | 4.3 |
| No | PAR 1 XSlope % | 4.3 |
| No | PAR 2 XSlope % | 3.9 |
| No | Clear Floor Space Slope % | 2.6 |

**Remove & Replace Boarding Area.  
Remove & Replace Sidewalk To  
Boarding Area. Remove & Replace  
Clear Floor Space.**
