# Access Compliance Report Public Rights-of-Way (Transit Stops)

| Intersection ID: 10012511 | Main Street: PEGRAM_ST | Cross Street: N/A | Location: W |
| ADA ID: 30D37B9CC2DB | Overall Compliance: No | Severity Score: 55 | |

CATS Stop Description: **Pegram St & Parkwood Ave**

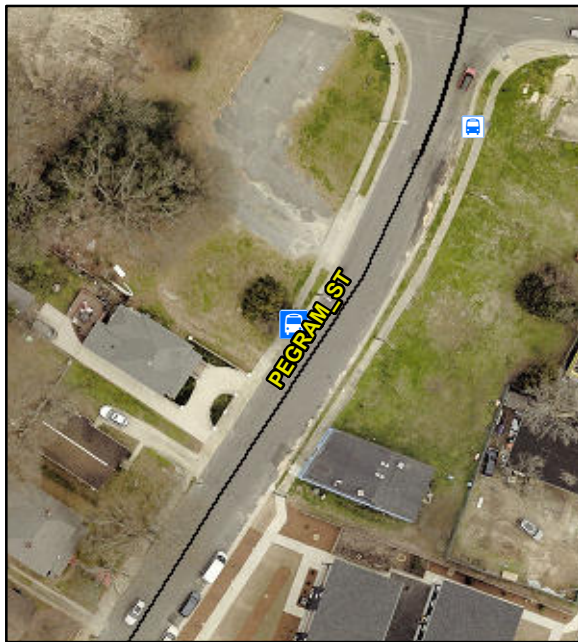
| Compliance | Description | Data |
|---|---|---|
| No | Boarding Area Length (in) | 74.0 |
| No | Boarding Area Slope % | 8.2 |
| No | Boarding Area XSlope % | 3.8 |
| No | PAR 2 Exist? | Yes |
| No | PAR 2 Slope % | 4.2 |
| No | Clear Floor Space | No |
| No | Protruding Objects? | Yes |

**Remove & Replace Boarding Area.  
Remove & Replace Sidewalk To  
Boarding Area. Provide Clear Floor  
Space. Remove or Relocate  
Protruding Objects/Obstructions.**
