# Access Compliance Report Public Rights-of-Way (Transit Stops)

| Intersection ID: 43133 | Main Street: STATESVILLE_AV | Cross Street: CARMINE_ST | Location: W |
| ADA ID: 367E358AA054 | Overall Compliance: No | Severity Score: 15 | |

CATS Stop Description: Statesville Ave & Carmine St

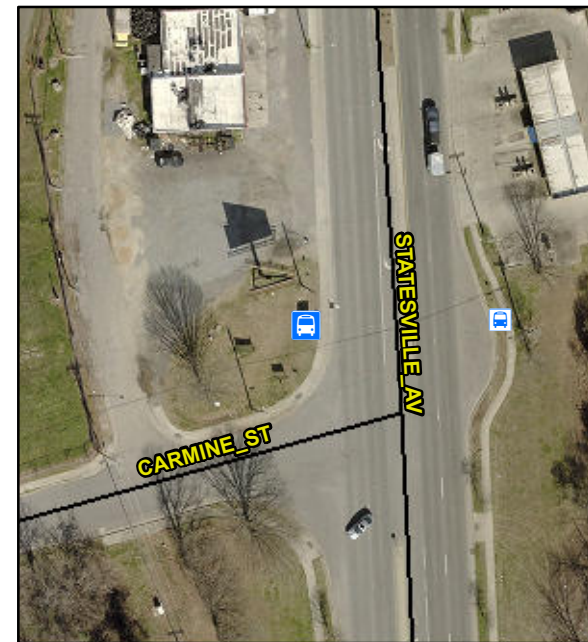
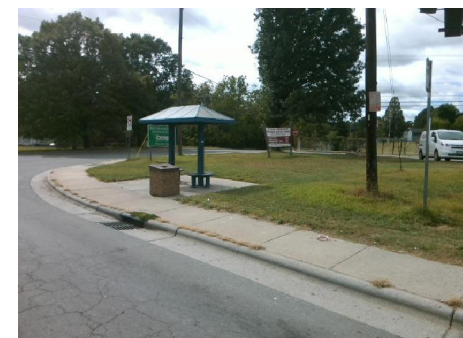
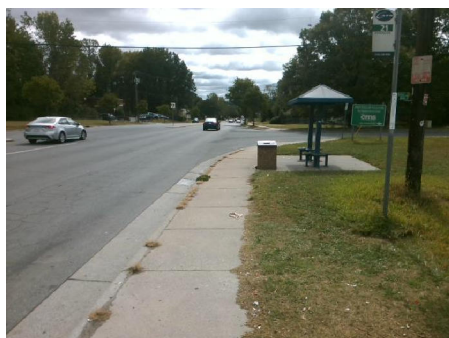
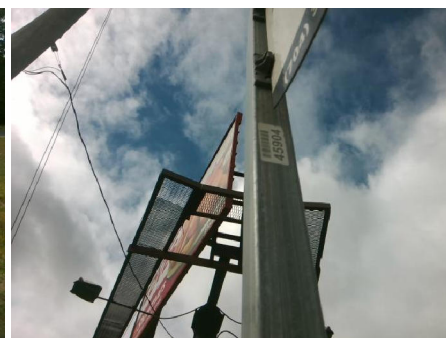
| Compliance | Description | Data |
|---|---|---|
| No | PAR 2 Exist? | Yes |
| No | PAR 2 Slope % | 3.5 |
| No | PAR 2 XSlope % | 3.0 |
| No | Clear Floor Space | Yes |
| No | Clear Floor Space XSlope % | 3.3 |
| No | Protruding Objects? | Yes |

**Remove & Replace Sidewalk To Boarding Area. Remove & Replace Clear Floor Space. Remove or Relocate Protruding Objects/Obstructions.**
