# Access Compliance Report Public Rights-of-Way (Transit Stops)

| Intersection ID: 10032746 | Main Street: N_SHARON_AMITY_RD | Cross Street: N/A | Location: W |
| ADA ID: 3C075BA96C76 | Overall Compliance: No | Severity Score: 40 | |

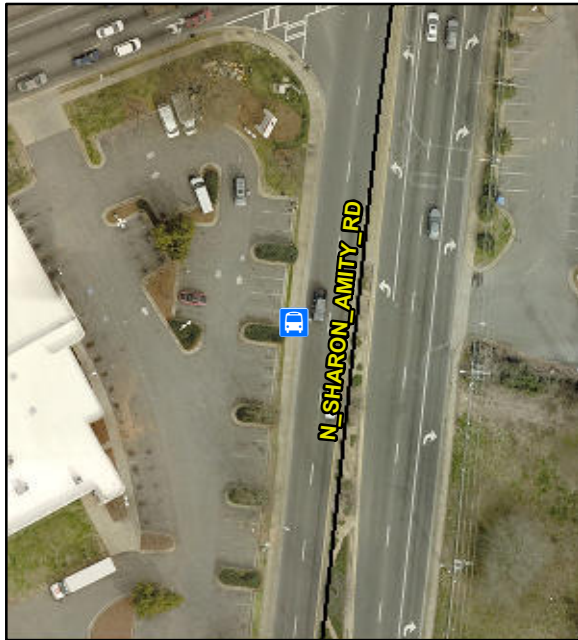
| Compliance | Description | Data |
|---|---|---|
| No | Boarding Area Length (in) | 78.0 |
| No | PAR 2 Exist? | Yes |
| No | PAR 2 XSlope % | 2.1 |

**Remove & Replace Boarding Area.  
Remove & Replace Sidewalk To  
Boarding Area.**
