# Access Compliance Report Public Rights-of-Way (Transit Stops)

| Intersection ID: 16251 | Main Street: N_SHARON_AMITY_RD | Cross Street: BUENA_VISTA_AV | Location: SE |
| ADA ID: 492735AC5FB8 | Overall Compliance: No | Severity Score: 85 | |

CATS Stop Description: Sharon Amity Rd & Buena Vista Ave

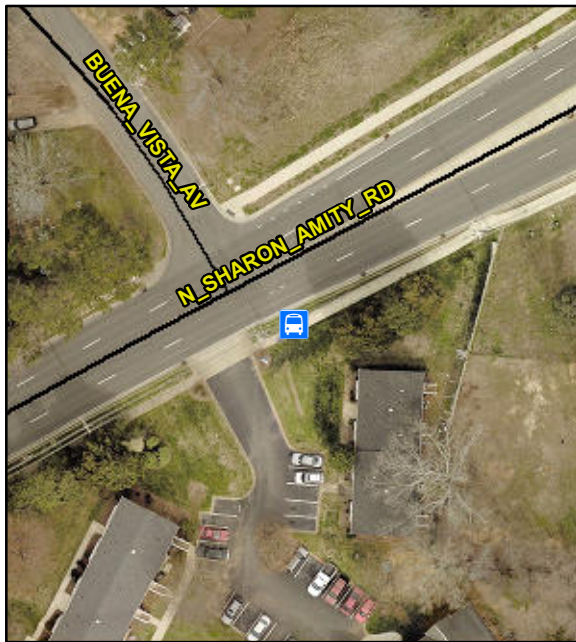
| Compliance | Description | Data |
|---|---|---|
| No | Boarding Area | No |
| No | PAR 1 Exist? | Yes |
| No | PAR 1 Slope % | 3.5 |
| No | Boarding Area Connected to PAR? | No |
| No | Clear Floor Space | No |

**Provide Boarding Area. Remove & Replace Sidewalk To Boarding Area. Provide Clear Floor Space.**
