# Access Compliance Report Public Rights-of-Way (Transit Stops)

| Intersection ID: 10027867 | Main Street: HAMLIN_PARK_DR | Cross Street: N/A | Location: NW |
| ADA ID: 4A78BED6F26B | Overall Compliance: No | Severity Score: 15 | |

CATS Stop Description: Hamlin Park Dr & Brandon Forest Dr

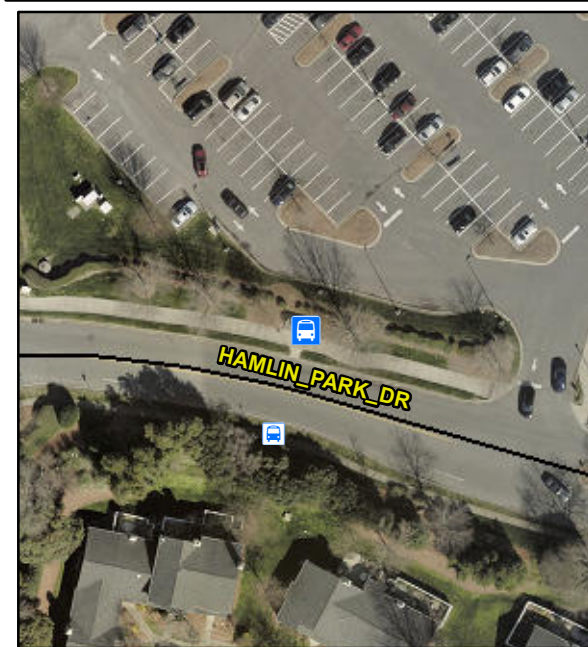
| Compliance | Description | Data |
|---|---|---|
| No | Boarding Area Slope % | 2.8 |
| No | Boarding Area XSlope % | 4.0 |
| No | Transit Sign? | No |
| No | Protruding Objects? | Yes |

**Remove & Replace Boarding Area.  
Remove or Relocate Protruding  
Objects/Obstructions. Provide  
Transit Stop Sign.**
