# Access Compliance Report Public Rights-of-Way (Transit Stops)

| Intersection ID: 10037289 | Main Street: SARDIS_RD_NORTH | Cross Street: N/A | Location: SE |
| ADA ID: 4DCC4B8FCA8A | Overall Compliance: No | Severity Score: 45 | |

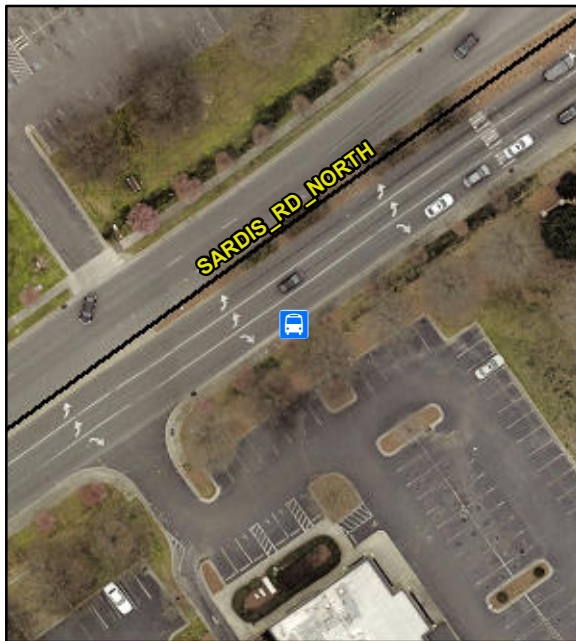
| Compliance | Description | Data |
|---|---|---|
| No | Boarding Area Length (in) | 66.0 |
| No | Boarding Area Slope % | 2.1 |
| No | Boarding Area XSlope % | 2.2 |

**Remove & Replace Boarding Area.**
