# Access Compliance Report Public Rights-of-Way (Transit Stops)

| Intersection ID: 10016035 | Main Street: THE_PLAZA | Cross Street: N/A | Location: N |
| ADA ID: 504A8546FD65 | Overall Compliance: No | Severity Score: 40 | |

CATS Stop Description: **The Plaza @ 6301 (car wash)**

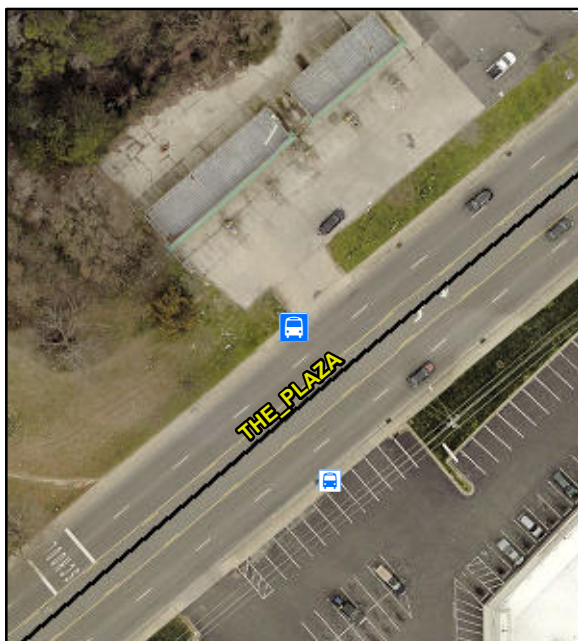
**810.2.2, R308.1.1.1**

| Compliance | Description | Data |
|---|---|---|
| No | Boarding Area Length (in) | 66.0 |

**Remove & Replace Boarding Area.**
