# Access Compliance Report Public Rights-of-Way (Transit Stops)

| Intersection ID: 10036993 | Main Street: S_TRYON_ST | Cross Street: W_CATHERINE_ST | Location: W |
| ADA ID: 56472C6440DA | Overall Compliance: No | Severity Score: 50 | |

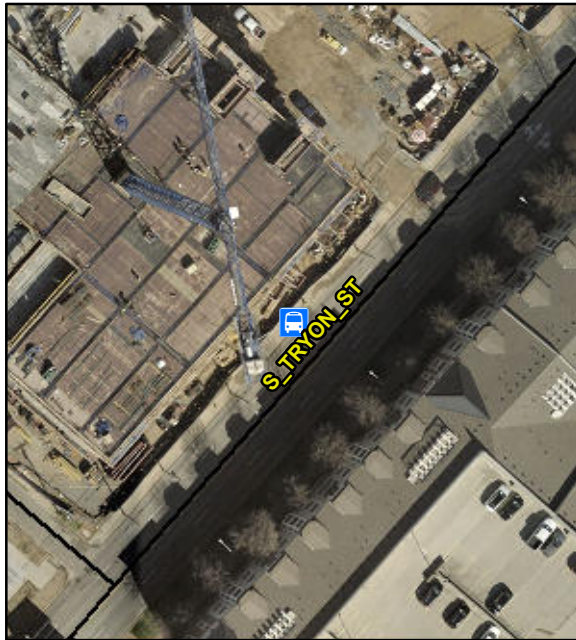
| Compliance | Description | Data |
|---|---|---|
| No | Boarding Area Length (in) | 71.0 |
| No | Boarding Area Slope % | 4.7 |
| No | PAR 1 Exist? | Yes |
| No | PAR 1 XSlope % | 4.7 |
| No | PAR 2 Exist? | Yes |

**Remove & Replace Boarding Area.  
Remove & Replace Sidewalk To  
Boarding Area. Provide Transit Stop  
Sign.**

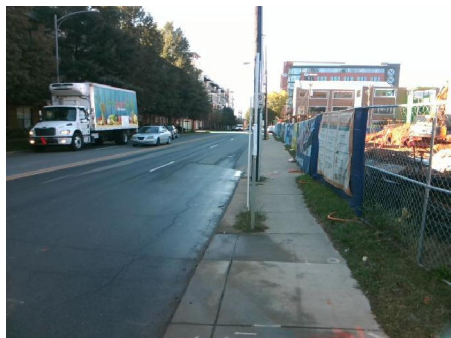
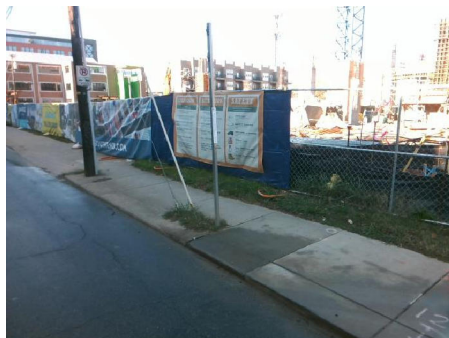
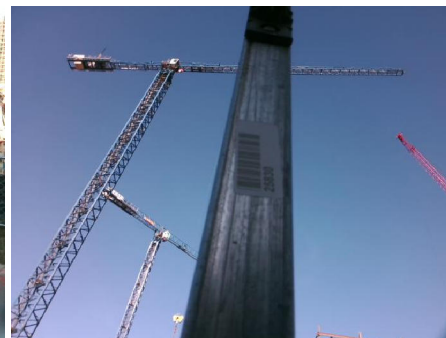
| Compliance | Description | Data |
|---|---|---|
| No | PAR 2 XSlope % | 5.0 |
| No | Transit Sign? | No |
