# Access Compliance Report Public Rights-of-Way (Transit Stops)

| Intersection ID: 10026316 | Main Street: FAIRVIEW_RD | Cross Street: N/A | Location: S |
| ADA ID: 5A05E7B4D202 | Overall Compliance: No | Severity Score: 50 | |

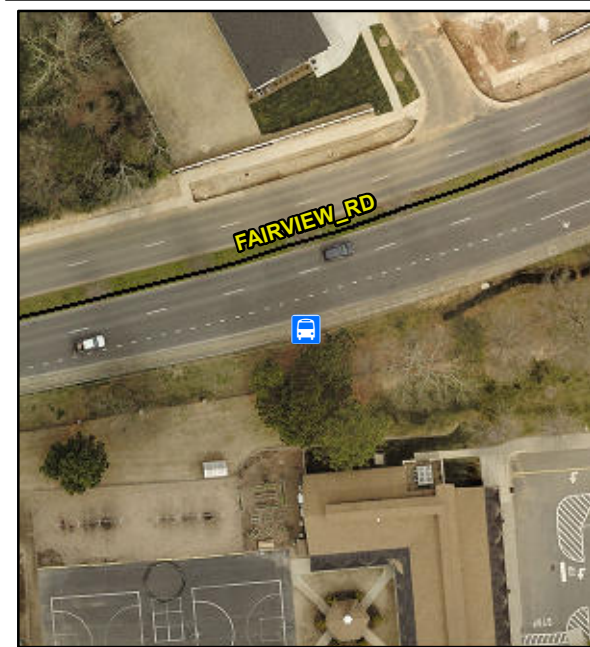
| Compliance | Description | Data |
|---|---|---|
| No | Boarding Area Length (in) | 69.0 |
| No | Boarding Area Slope % | 2.5 |
| No | Boarding Area XSlope % | 3.8 |
| No | PAR 1 Slope % | 3.8 |
| No | PAR 1 XSlope % | 2.5 |
| No | PAR 2 Slope % | 3.0 |

**Remove & Replace Boarding Area.  
Remove & Replace Sidewalk To  
Boarding Area.**
