# Access Compliance Report Public Rights-of-Way (Transit Stops)

| Intersection ID: 10032284 | Main Street: MOUNT_HOLLY_RD | Cross Street: N/A | Location: E |
| ADA ID: 5A61E1DF4C7E | Overall Compliance: No | Severity Score: 100 | |

CATS Stop ID: N/A  
 CATS Stop Description: Mt Holly Rd & Sonoma Valley Dr  
 CATS Route ID: 18  
 CATS Route Name: Paw Creek / Rosa Parks

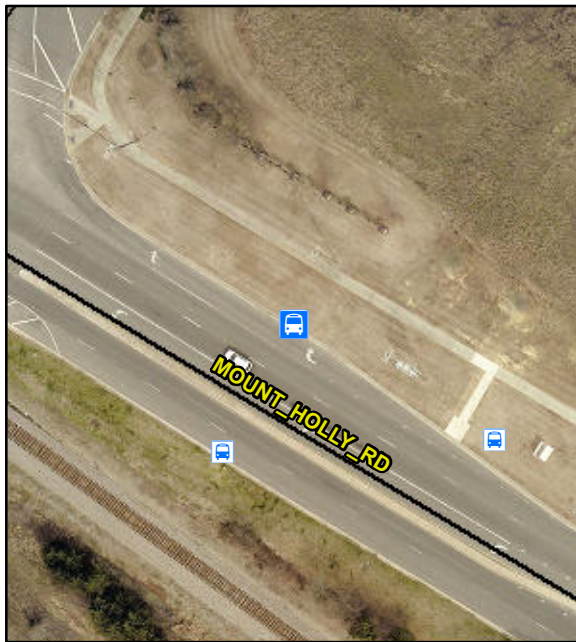
**TRANSIT STOP DOES NOT EXISTS, CREATED NEW MARKER FOR NEW TRANSIT STOP LOCATION**

| Compliance | Description | Data |
|---|---|---|
| No | Boarding Area | No |
| No | PAR 1 Exist? | No |
| N/A | Boarding Area Connected to PAR? | No |

**Provide Boarding Area. Provide Sidewalk To Boarding Area.**

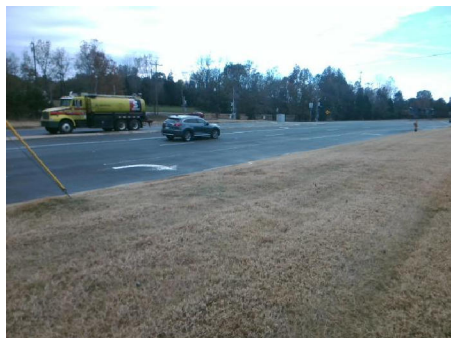
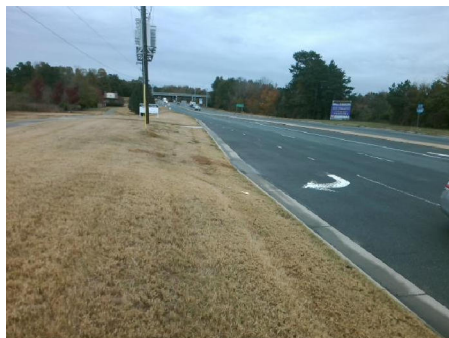
| Compliance | Description | Data |
|---|---|---|
| Yes | Transit Sign? | Yes |
| Yes | Transit Sign Height (in) | 95.0 |
