# Access Compliance Report Public Rights-of-Way (Transit Stops)

| Intersection ID: 10011372 | Main Street: W_SUGAR_CREEK_RD | Cross Street: N/A | Location: W |
| ADA ID: 5EBDAAC403FD | Overall Compliance: No | Severity Score: 100 | |

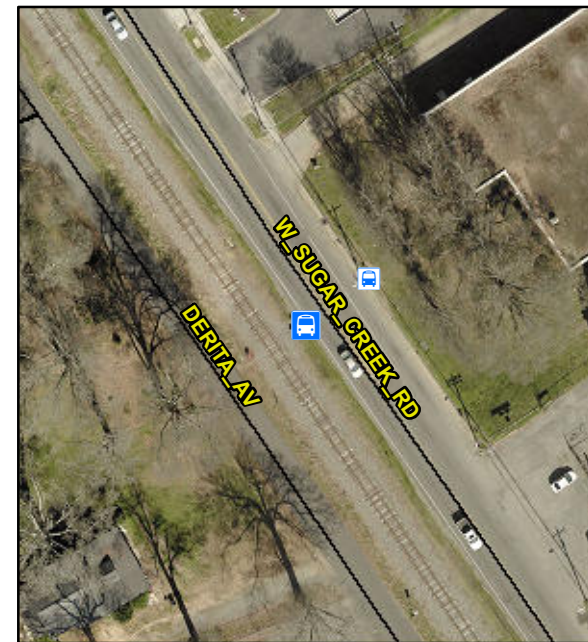
**UNABLE TO VERIFY CATS ID, POSTS SHOW LAST FIUR NUMBERS 5270**

| Compliance | Description | Data |
|---|---|---|
| No | Boarding Area | No |
| No | PAR 1 Exist? | No |

**Provide Boarding Area. Provide Sidewalk To Boarding Area. Remove or Relocate Protruding Objects/Obstructions.**

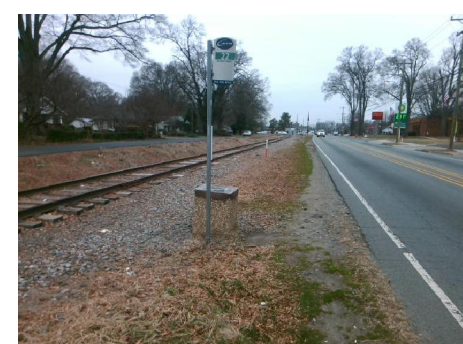
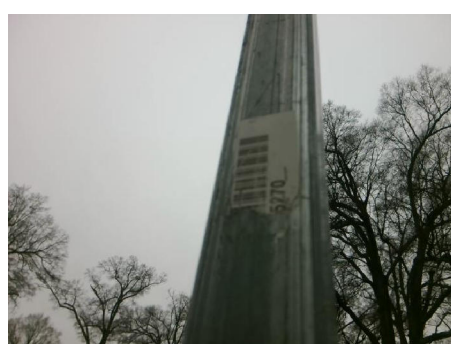
| Compliance | Description | Data |
|---|---|---|
| No | Protruding Objects? | Yes |
