# Access Compliance Report Public Rights-of-Way (Transit Stops)

| Intersection ID: 10028921 | Main Street: IDLEWILD_RD | Cross Street: CEDARS_EAST_CT | Location: S |
| ADA ID: 6348F439899D | Overall Compliance: No | Severity Score: 75 | |

CATS Stop ID: **38330**  
 CATS Stop Description: **Idlewild Rd & Cedars East Ct**  
 CATS Route ID: **221, 52x**  
 CATS Route Name: **Multiple**

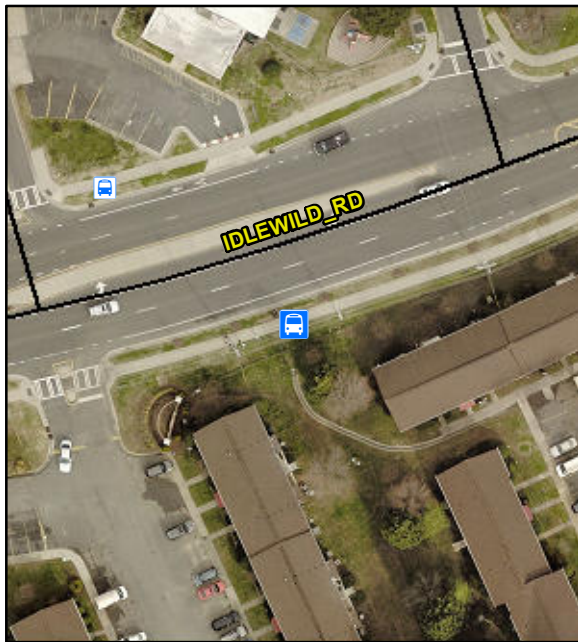
| Compliance | Description | Data |
|---|---|---|
| No | Boarding Area | No |
| No | Boarding Area Connected to PAR? | No |

**Provide Boarding Area. Provide Sidewalk Connection to Boarding Area. Provide Clear Floor Space. Remove or Relocate Protruding Objects/Obstructions.**

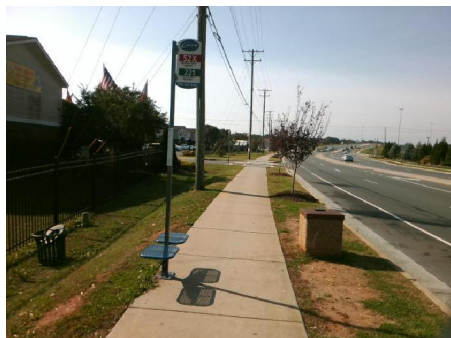
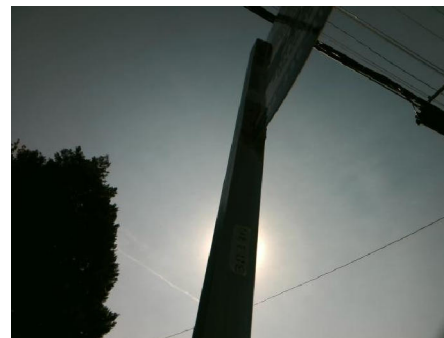
| Compliance | Description | Data |
|---|---|---|
| No | Clear Floor Space | No |
| No | Protruding Objects? | Yes |
