# Access Compliance Report

## Public Rights-of-Way

### (Transit Stops)

CATS Stop Description: College St & Stonewall St

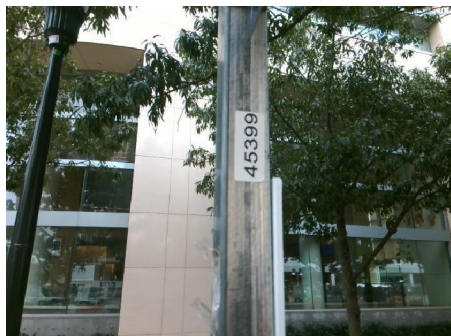
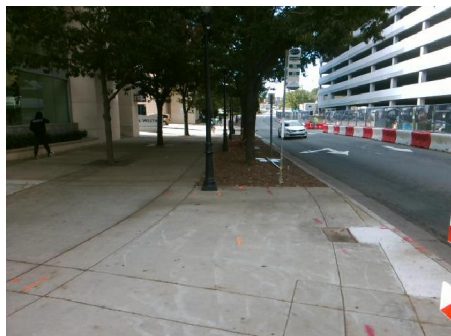
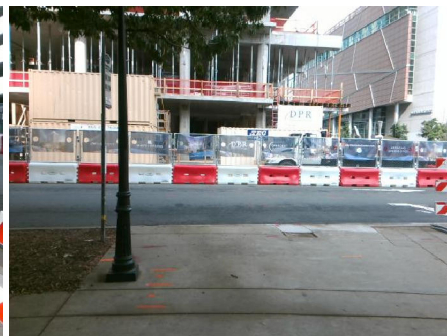
| Compliance | Description | Data |
|---|---|---|
| Yes | Boarding Area | Yes |
| Yes | Boarding Area Width (in) | 120.0 |
| Yes | Boarding Area Length (in) | 120.0 |
| Yes | Boarding Area Slope % | 0.9 |
| Yes | Boarding Area XSlope % | 0.1 |
| Yes | Transit Sign? | Yes |
| Yes | Transit Sign Height (in) | 93.5 |
| Yes | Protruding Objects? | No |
