# Access Compliance Report Public Rights-of-Way (Transit Stops)

| Intersection ID: 50041 | Main Street: METROPOLITAN_AV | Cross Street: CHARLOTTETOWNE_AV | Location: SW |
| ADA ID: 673FF71C7556 | Overall Compliance: No | Severity Score: 40 | |

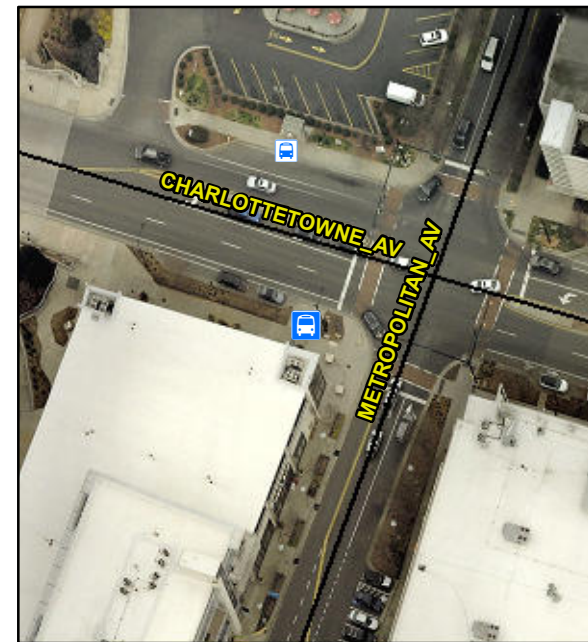
**STOP NOT IN SERVICE**

| Compliance | Description | Data |
|---|---|---|
| No | Boarding Area Slope % | 2.8 |
| No | PAR 1 Exist? | Yes |
| No | PAR 1 XSlope % | 2.3 |
| No | Clear Floor Space | No |
| No | Protruding Objects? | Yes |

**Remove & Replace Boarding Area.  
Remove & Replace Sidewalk To  
Boarding Area. Provide Clear Floor  
Space. Remove or Relocate  
Protruding Objects/Obstructions.**
