# Access Compliance Report Public Rights-of-Way (Transit Stops)

| Intersection ID: 10025277 | Main Street: E_3RD_ST | Cross Street: N/A | Location: S |
| ADA ID: 73637D1B2046 | Overall Compliance: No | Severity Score: 40 | |

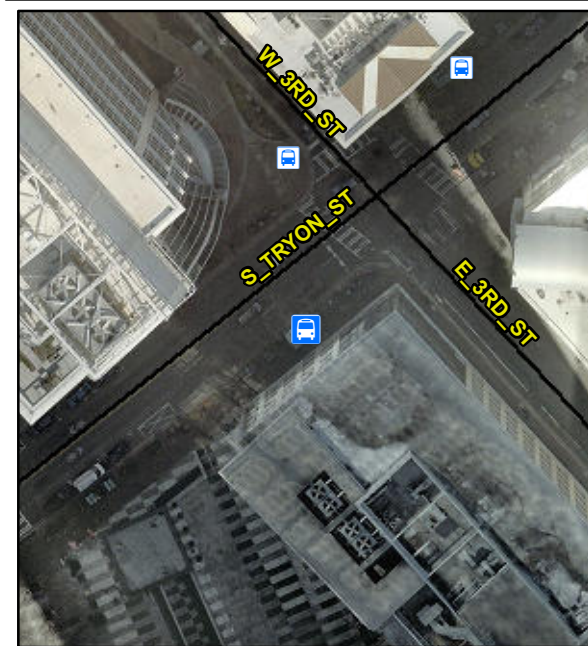
**UNABLE TO VERIFY CATS ID,  
SHELTER LISTS AS CATS TRANSIT  
SYSTEM**

| Compliance | Description | Data |
|---|---|---|
| No | Boarding Area Width (in) | 55.0 |
| No | Boarding Area Slope % | 8.6 |
| No | PAR 1 XSlope % | 4.7 |
| No | PAR 2 Slope % | 3.2 |
| No | PAR 2 XSlope % | 6.1 |
| No | Clear Floor Space | Yes |
| No | Clear Floor Space Slope % | 8.6 |
| No | Transit Sign? | No |

**Remove & Replace Boarding Area.  
Remove & Replace Sidewalk To  
Boarding Area. Remove & Replace  
Clear Floor Space. Provide Transit  
Stop Sign.**
