# Access Compliance Report Public Rights-of-Way (Transit Stops)

| Intersection ID: 1001921 | Main Street: PROSPERITY_CHURCH_RD | Cross Street: N/A | Location: S |
| ADA ID: 78772EE14952 | Overall Compliance: No | Severity Score: 45 | |

CATS Stop Description: **Prosperity Church Rd & Katelyn Dr**

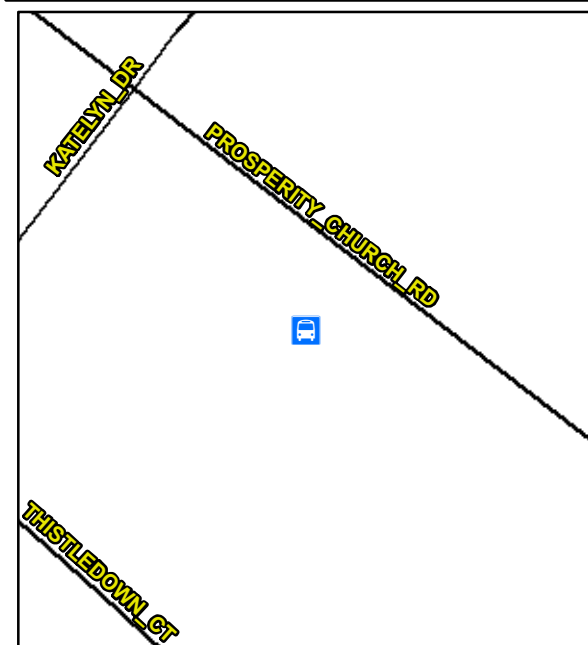
| Compliance | Description | Data |
|---|---|---|
| No | Boarding Area Length (in) | 88.0 |
| No | Boarding Area XSlope % | 2.5 |
| No | PAR 1 Exist? | Yes |
| No | PAR 1 Slope % | 2.5 |
| No | Transit Sign Height (in) | 50.0 |

**Remove & Replace Boarding Area.  
Remove & Replace Sidewalk To  
Boarding Area. Adjust Transit Stop  
Sign Height.**
