# Access Compliance Report Public Rights-of-Way (Transit Stops)

| Intersection ID: -9999 | Main Street: Catawba Ave | Cross Street: N/A | Location: N |
| ADA ID: 7A6C20C8B8BD | Overall Compliance: No | Severity Score: 45 | |

CATS Stop Description: **Catawba Ave & Mulberry St**

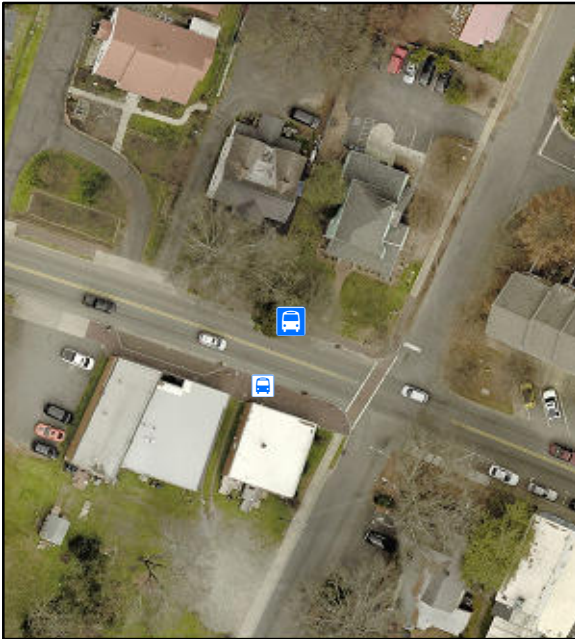
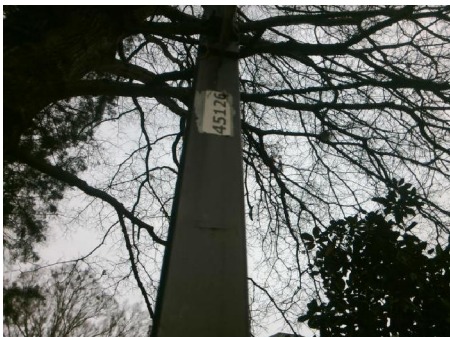
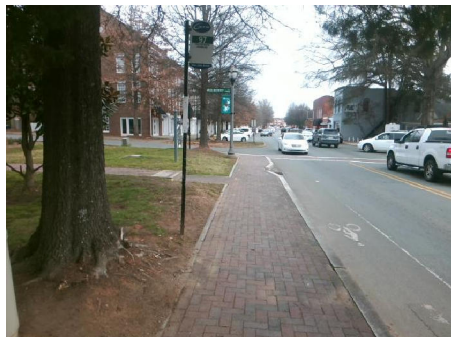
| Compliance | Description | Data |
|---|---|---|
| No | Boarding Area Length (in) | 75.0 |
| No | Boarding Area Slope % | 3.1 |
| No | PAR 1 Exist? | Yes |
| No | PAR 1 XSlope % | 3.1 |
| No | PAR 2 Exist? | Yes |
| No | PAR 2 XSlope % | 3.6 |

**Remove & Replace Boarding Area.  
Remove & Replace Sidewalk To  
Boarding Area.**
