# Access Compliance Report Public Rights-of-Way (Transit Stops)

| Intersection ID: 10032177 | Main Street: MORRIS_FIELD_DR | Cross Street: N/A | Location: S |
| ADA ID: 7D938102F22B | Overall Compliance: No | Severity Score: 35 | |

CATS Stop Description: Morris Field Dr & CPCC Harris Campus Dr

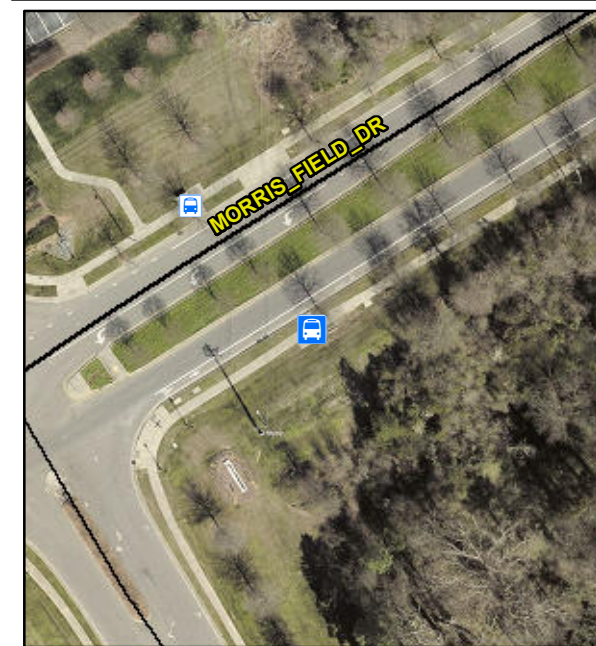
| Compliance | Description | Data |
|---|---|---|
| No | Boarding Area Width (in) | 59.0 |
| No | Boarding Area Slope % | 5.4 |
| No | PAR 1 Exist? | Yes |
| No | PAR 1 XSlope % | 2.8 |
| No | PAR 2 Exist? | Yes |
| No | PAR 2 Slope % | 3.0 |
| No | PAR 2 XSlope % | 2.3 |
| No | Clear Floor Space | Yes |
| No | Clear Floor Space Slope % | 2.5 |
| No | Clear Floor Space XSlope % | 3.1 |

**Remove & Replace Boarding Area.  
Remove & Replace Sidewalk To  
Boarding Area. Remove & Replace  
Clear Floor Space.**
