# Access Compliance Report Public Rights-of-Way (Transit Stops)

| Intersection ID: 10027867 | Main Street: HAMLIN_PARK_DR | Cross Street: N/A | Location: SW |
| ADA ID: 90C62D20288A | Overall Compliance: No | Severity Score: 90 | |

CATS Stop Description: **Hamlin Park Dr & Brandon Forest Dr**

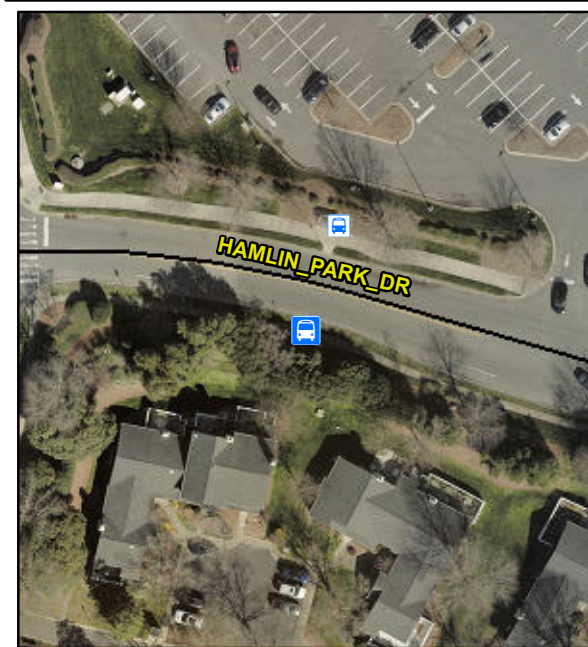
| Compliance | Description | Data |
|---|---|---|
| No | Boarding Area | No |
| No | PAR 1 Exist? | Yes |
| No | PAR 1 Width (in) | 47.0 |
| No | PAR 1 XSlope % | 3.0 |
| No | Boarding Area Connected to PAR? | No |

**Provide Boarding Area. Remove & Replace Sidewalk To Boarding Area.**
