# Access Compliance Report

## Public Rights-of-Way

### (Transit Stops)

| Intersection ID: 10040526 | Main Street: W_5TH_ST | Cross Street: N_CEDAR_ST | Location: S |

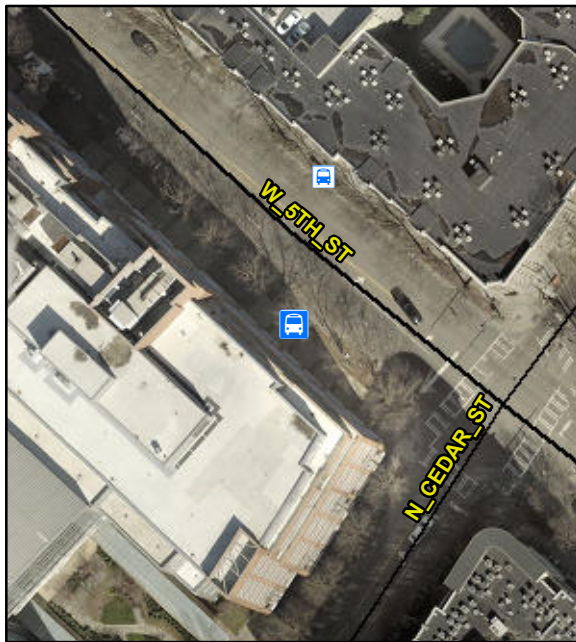
**METAL GRADING WITHING  
BOARDING ARWA**

| Compliance | Description | Data |
|---|---|---|
| No | Boarding Area Length (in) | 78.0 |
| No | Boarding Area XSlope % | 3.8 |
| No | PAR 1 Slope % | 2.3 |
| No | PAR 2 XSlope % | 2.3 |
| No | Protruding Objects? | Yes |

**Remove & Replace Boarding Area.  
Remove & Replace Sidewalk To  
Boarding Area. Remove or Relocate  
Protruding Objects/Obstructions.**
