# Access Compliance Report Public Rights-of-Way (Transit Stops)

| Intersection ID: 50272 | Main Street: SOUTH_BV | Cross Street: WHITTON_ST | Location: SE |
| ADA ID: 983C9096E0BA | Overall Compliance: No | Severity Score: 55 | |

CATS Stop Description: **South Blvd & Whitton St**

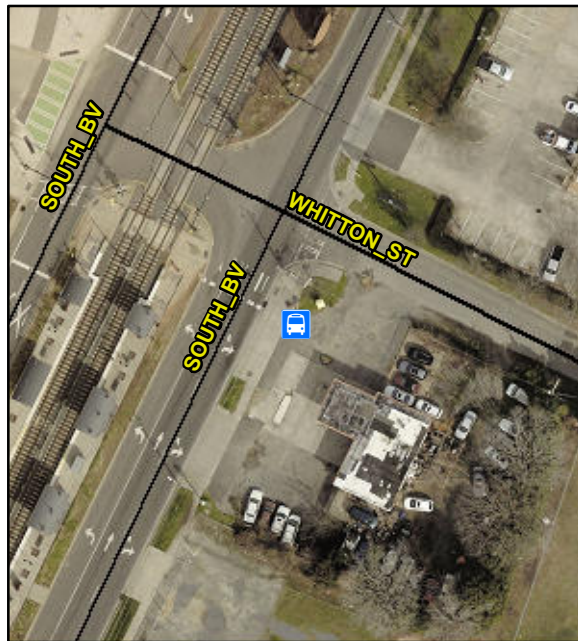
| Compliance | Description | Data |
|---|---|---|
| No | Boarding Area Width (in) | 48.5 |
| No | Boarding Area Slope % | 4.3 |
| No | PAR 1 Width (in) | 40.0 |
| No | PAR 1 Slope % | 2.9 |
| No | PAR 1 XSlope % | 2.6 |

**Remove & Replace Boarding Area.  
Remove & Replace Sidewalk To  
Boarding Area. Provide Clear Floor  
Space. Remove or Relocate  
Protruding Objects/Obstructions.**

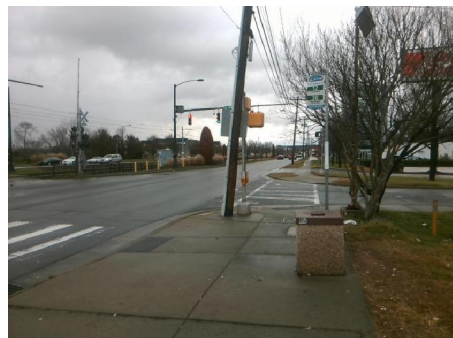
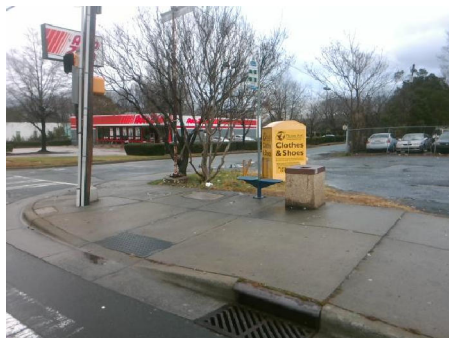
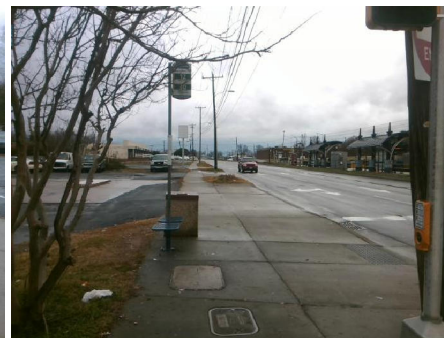
| Compliance | Description | Data |
|---|---|---|
| No | PAR 2 XSlope % | 2.4 |
| No | Clear Floor Space | No |
| No | Protruding Objects? | Yes |
