# Access Compliance Report Public Rights-of-Way (Transit Stops)

| Intersection ID: 10036729 | Main Street: S_CRIGLER_ST | Cross Street: N/A | Location: W |
| ADA ID: 9C574ECC4CB1 | Overall Compliance: No | Severity Score: 100 | |

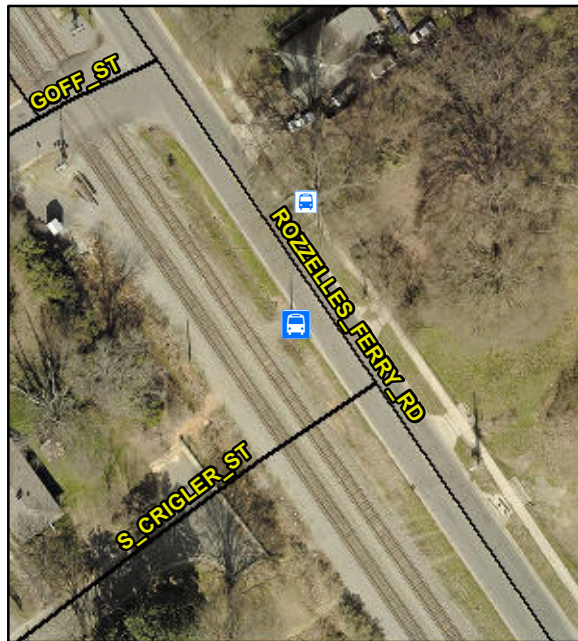
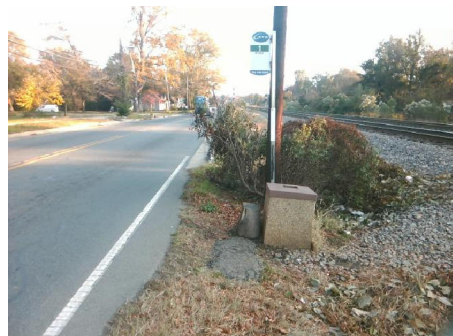
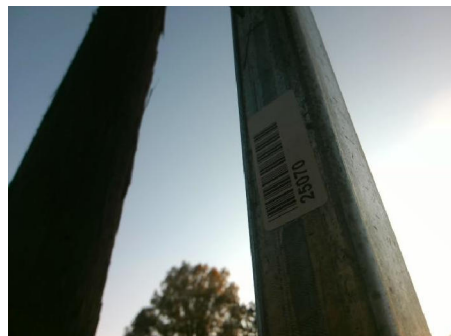
| Compliance | Description | Data |
|---|---|---|
| No | Boarding Area | No |
| No | PAR 1 Exist? | No |
| N/A | Boarding Area Connected to PAR? | No |
| No | Protruding Objects? | Yes |

**Provide Boarding Area. Provide Sidewalk To Boarding Area. Remove or Relocate Protruding Objects/Obstructions.**
