# Access Compliance Report

## Public Rights-of-Way

### (Transit Stops)

| Intersection ID: 23827 | Main Street: CULP_RD | Cross Street: E_WESTINGHOUSE_BV | Location: S |

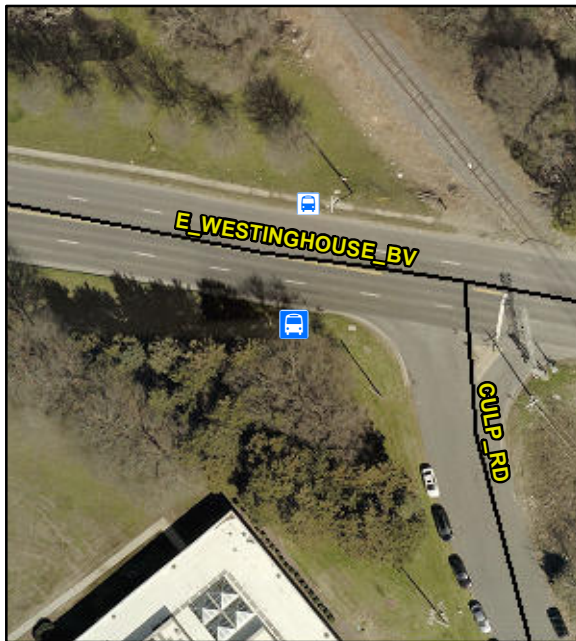
| ADA ID: 9E587F1434BE | Overall Compliance: No | Severity Score: 100 | |

| Compliance | Description | Data |
|---|---|---|
| No | Boarding Area | No |
| No | PAR 1 Exist? | No |

**Provide Boarding Area. Provide Sidewalk To Boarding Area.**

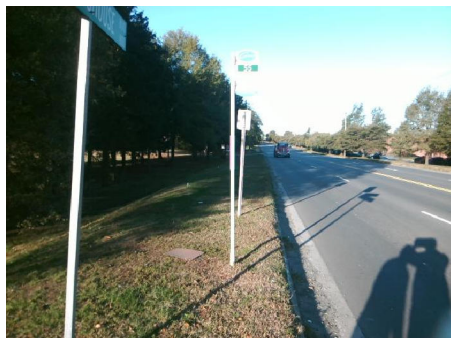
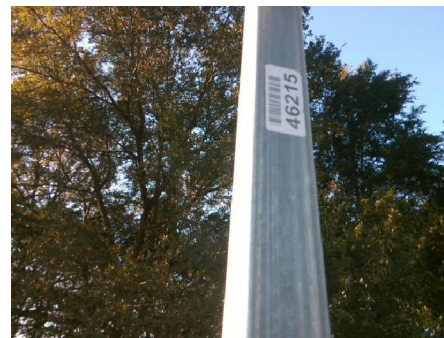
| Compliance | Description | Data |
|---|---|---|
| N/A | Boarding Area Connected to PAR? | No |

Possible Solutions:
