# Access Compliance Report

## Public Rights-of-Way

### (Transit Stops)

| Intersection ID: 8988 | Main Street: NORRIS_AV | Cross Street: OLANDO_ST | Location: N |

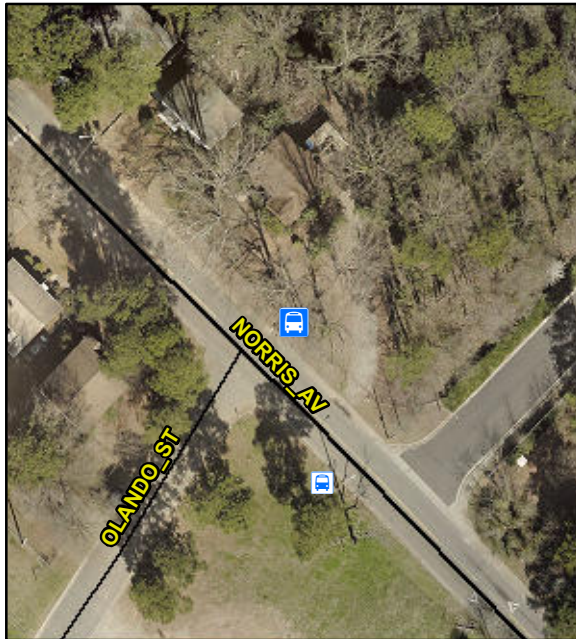
**CURB WIDTH 16.0 IN**

| Compliance | Description | Data |
|---|---|---|
| No | Boarding Area Length (in) | 54.0 |
| No | Boarding Area Slope % | 4.7 |
| No | PAR 1 Width (in) | 38.0 |
| No | PAR 1 XSlope % | 4.7 |
| No | PAR 2 Width (in) | 38.0 |
| No | PAR 2 Slope % | 2.8 |
| No | PAR 2 XSlope % | 5.1 |
| No | Protruding Objects? | Yes |

**Remove & Replace Boarding Area.  
Remove & Replace Sidewalk To  
Boarding Area. Remove or Relocate  
Protruding Objects/Obstructions.**
