# Access Compliance Report Public Rights-of-Way (Transit Stops)

| Intersection ID: 10011407 | Main Street: N_DAVIDSON_ST | Cross Street: N/A | Location: S |
| ADA ID: AC0C660AC930 | Overall Compliance: No | Severity Score: 40 | |

CATS Stop Description: Davidson St & 36th St

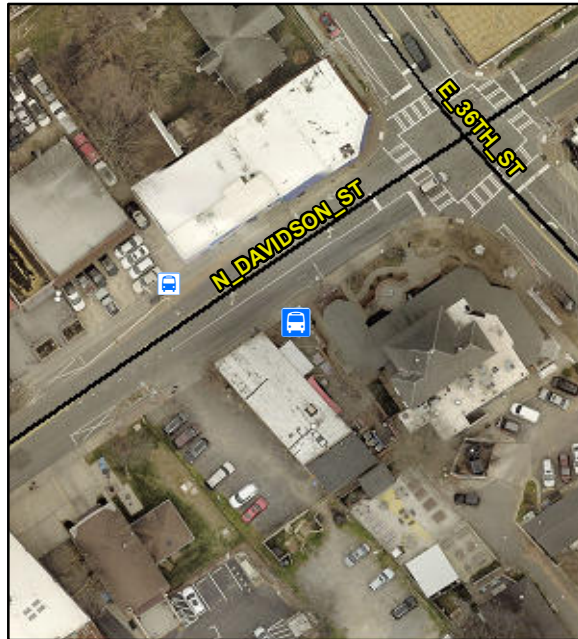
**CATS ID NOT LISTED AT TRANSIT  
STOP**

| Compliance | Description | Data |
|---|---|---|
| No | Boarding Area Length (in) | 65.0 |
| No | Boarding Area Slope % | 2.7 |
| No | PAR 1 Exist? | Yes |
| No | PAR 1 XSlope % | 2.7 |

**Remove & Replace Boarding Area.  
Remove & Replace Sidewalk To  
Boarding Area. Remove or Relocate  
Protruding Objects/Obstructions.**

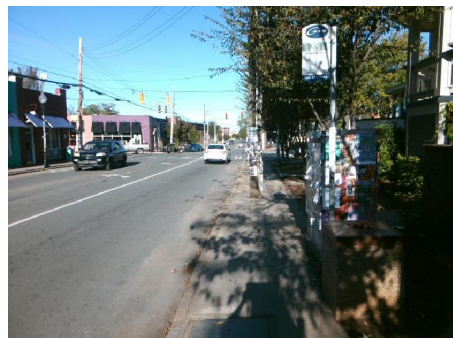
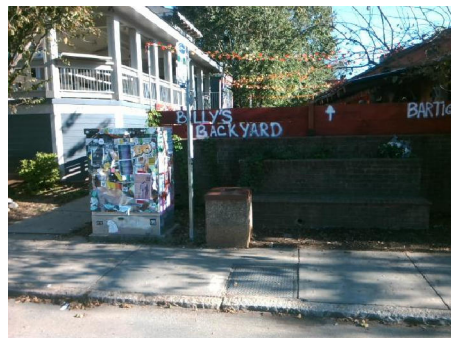
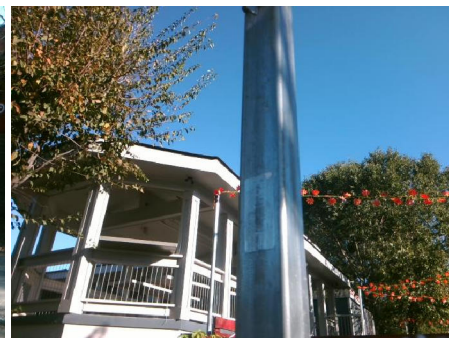
| Compliance | Description | Data |
|---|---|---|
| No | Protruding Objects? | Yes |

Possible Solutions:
