# Access Compliance Report

## Public Rights-of-Way

### (Transit Stops)

| Intersection ID: 15028 | Main Street: CLANTON_RD | Cross Street: FIELDCREST_RD | Location: E |

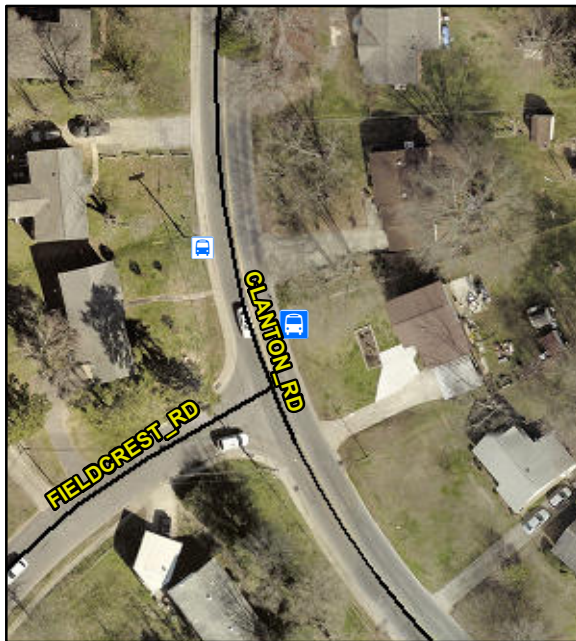
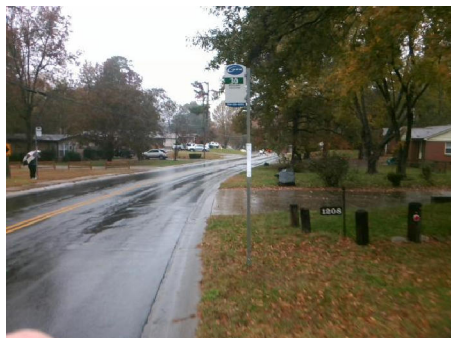
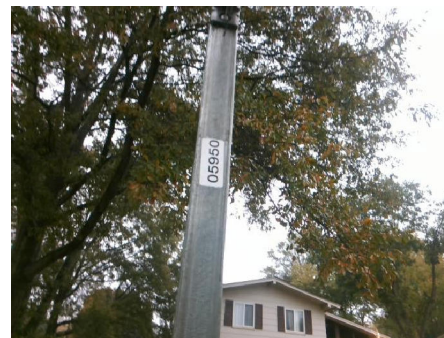
| Compliance | Description | Data |
|---|---|---|
| No | Boarding Area | No |
| No | PAR 1 Exist? | No |
| N/A | Boarding Area Connected to PAR? | No |
| N/A | Road Slope % | 5.9 |

**Provide Boarding Area. Provide Sidewalk To Boarding Area.**
