# Access Compliance Report Public Rights-of-Way (Transit Stops)

| Intersection ID: 10032798 | Main Street: N_WENDOVER_RD | Cross Street: N/A | Location: NW |
| ADA ID: C9AE2E069BE0 | Overall Compliance: No | Severity Score: 85 | |

CATS Stop ID: **49337**  
 CATS Stop Description: **Wendover Rd & Latrobe Dr**  
 CATS Route ID: **39**  
 CATS Route Name: **Eastway Drive**

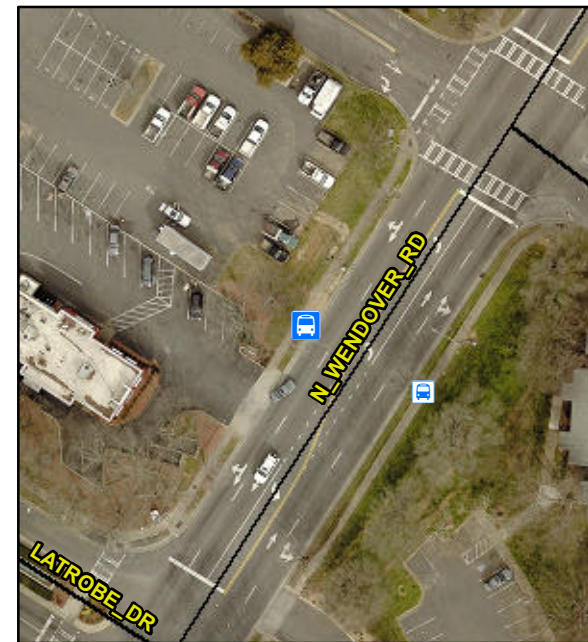
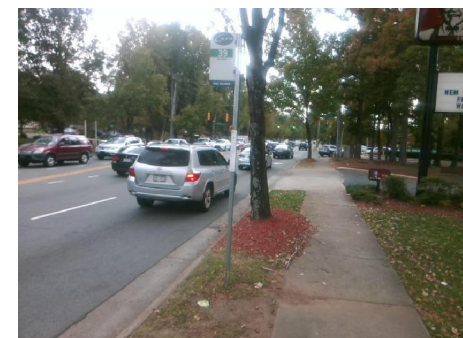
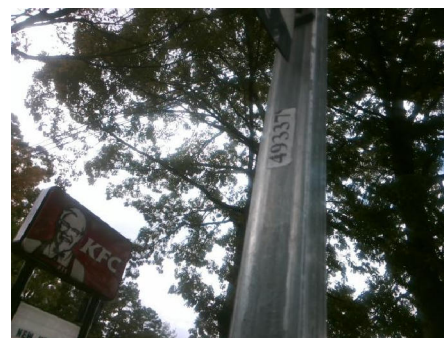
| Compliance | Description | Data |
|---|---|---|
| No | Boarding Area | No |
| No | PAR 1 Exist? | Yes |
| No | PAR 1 Slope % | 2.4 |
| No | Boarding Area Connected to PAR? | No |

**Provide Boarding Area. Remove & Replace Sidewalk To Boarding Area.**
